C-1: *2009 Maintenance and Repair Report and Annual Inspection Report,  
Southwest Funston Landfill, Fort Riley, Kansas, June 10, 2009 and  
Photographs of the Site Access Controls, the Landfill Cover Repair and the  
Rock Armoring of the Upper Riverbank Slope in September-October 2009*

## MAINTENANCE AND REPAIR REPORT

## ANNUAL INSPECTION REPORT

### SOUTHWEST FUNSTON LANDFILL

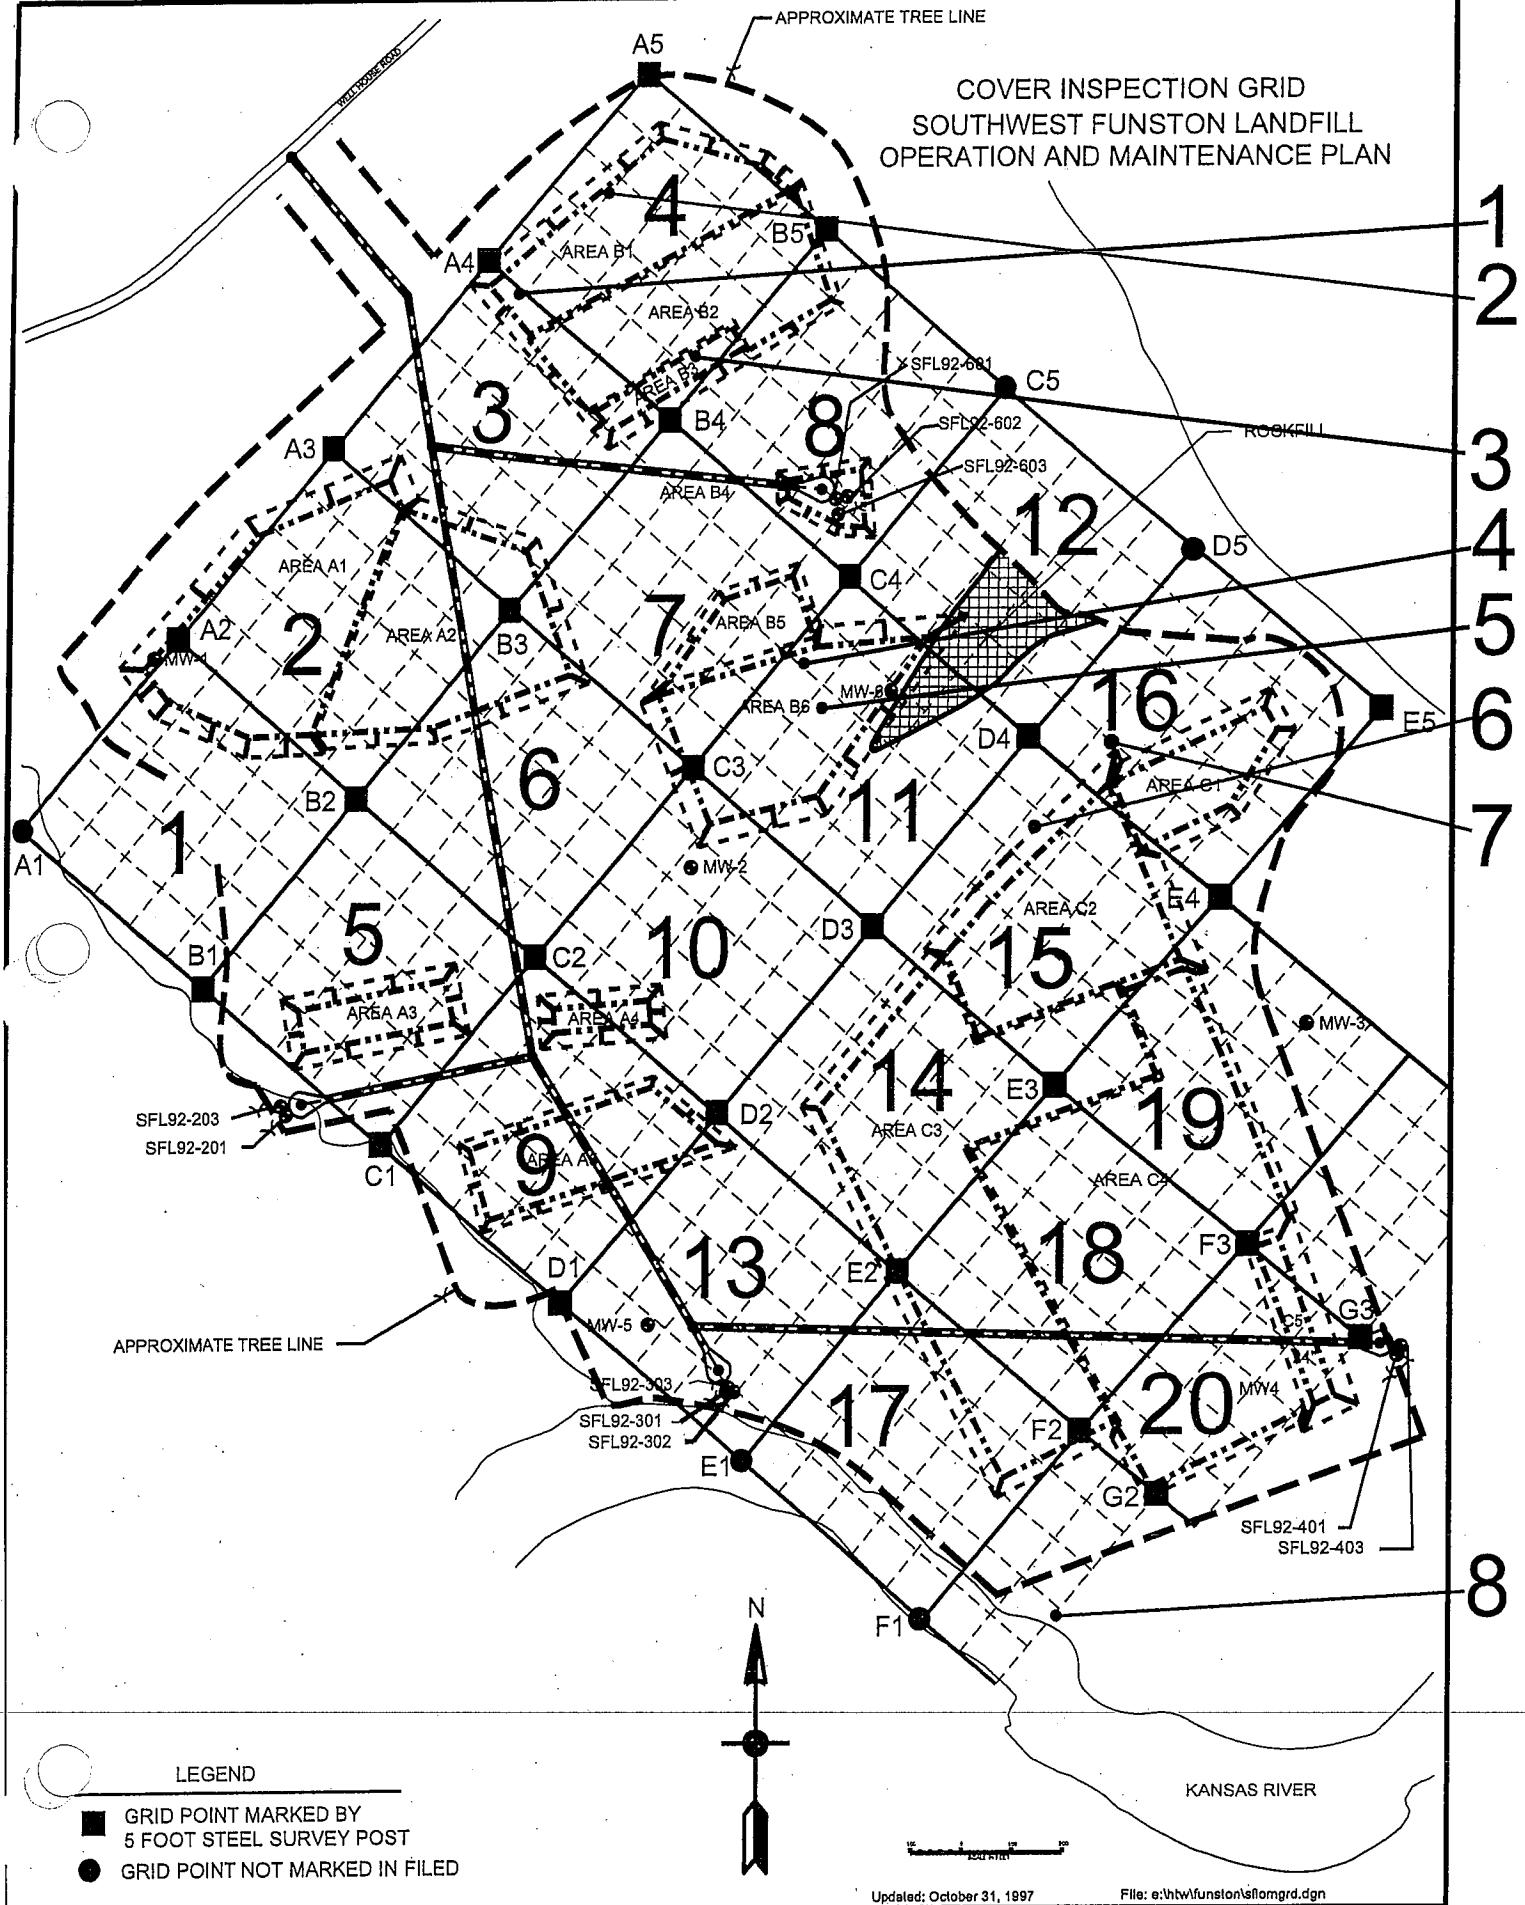
Figure 1 - Location of photographs taken during May 11, 2009 inspection.

- The grasses on the landfill were burned on April 22, 2009 which provided an excellent opportunity to observe and record the location of depressions on the landfill surface. The coordinates of photographs taken of observed differential settlement, ponded areas and eroded areas during this inspection are provided in Table 1 and the locations are plotted on Figure 1. The photographs are included in Attachment A to this report. These areas will be included in the next cover repair project that is currently scheduled for 2013.

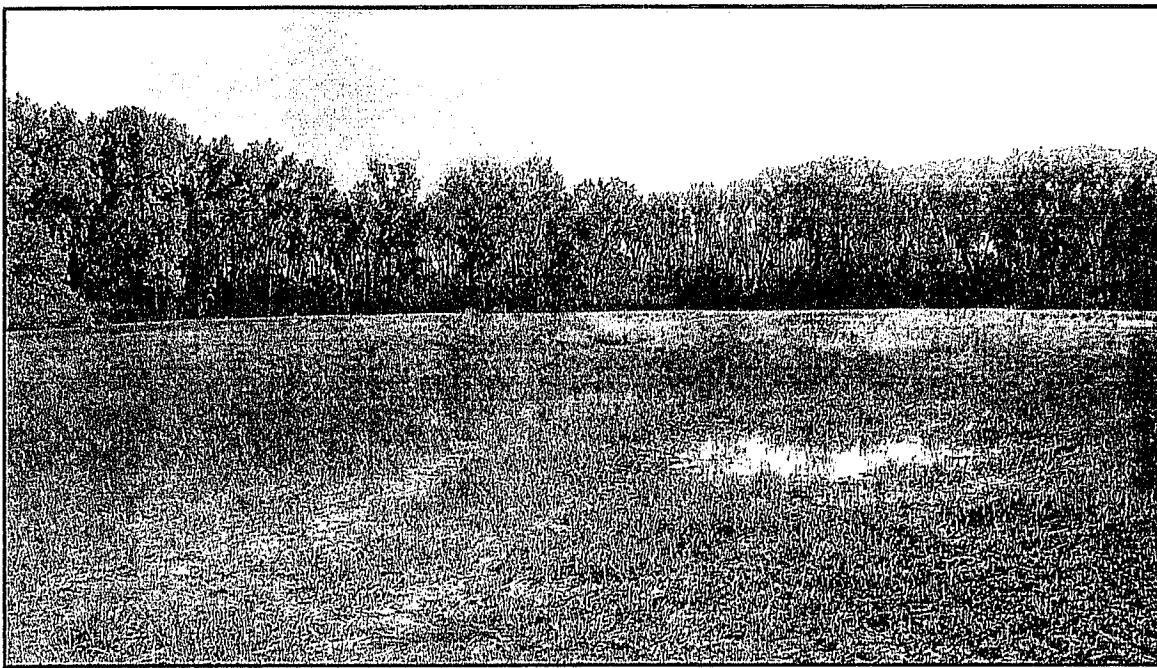
Photograph SFL2009-1 – View looking east of differential settlement/ponding in northeast quadrant of landfill (11May 09).

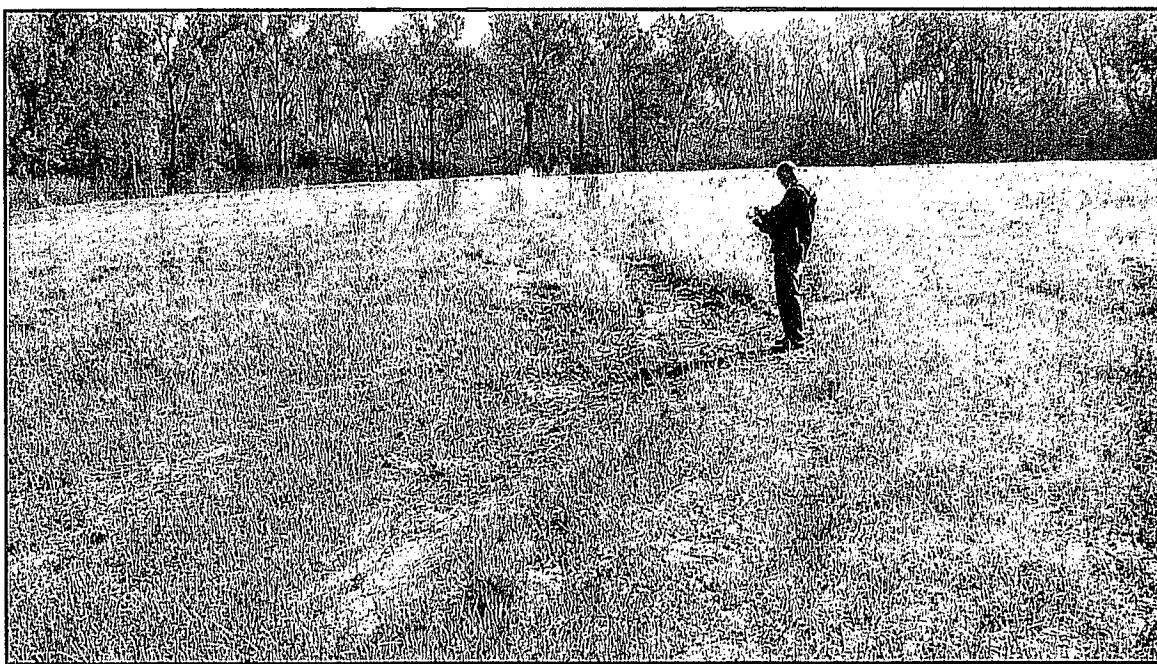
Photograph SFL2009-2 – View looking east of standing water in northeast quadrant of landfill (11 May 09).

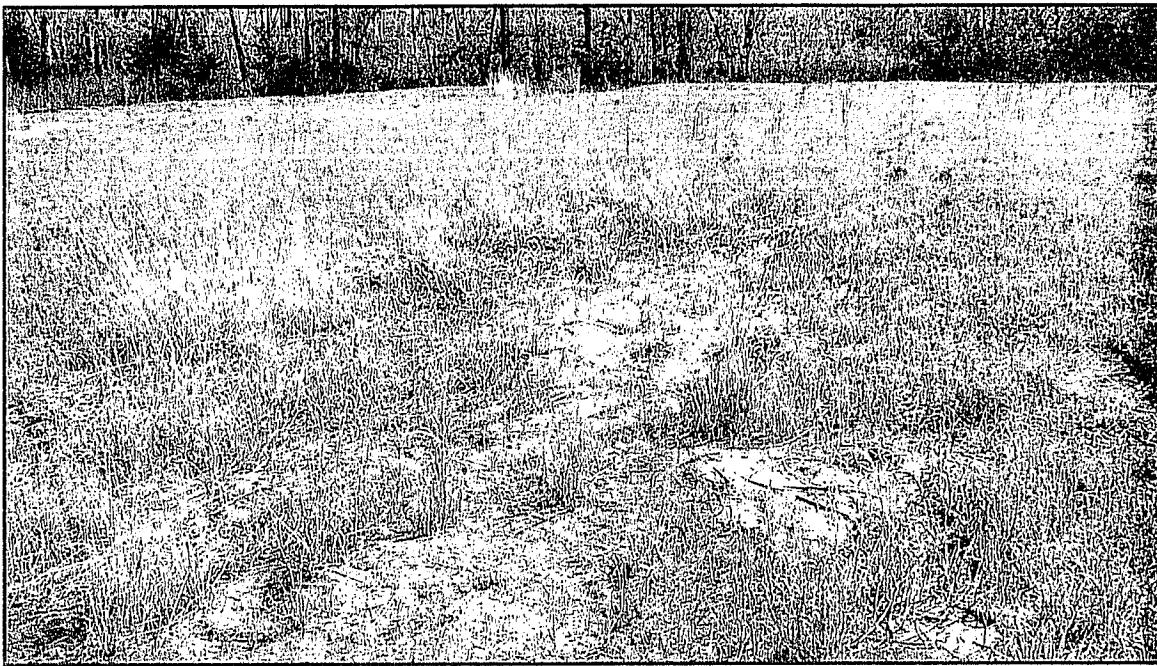
Photograph SFL2009-3 – View looking east at newly repaired area in northeast quadrant of landfill (11 May 09).

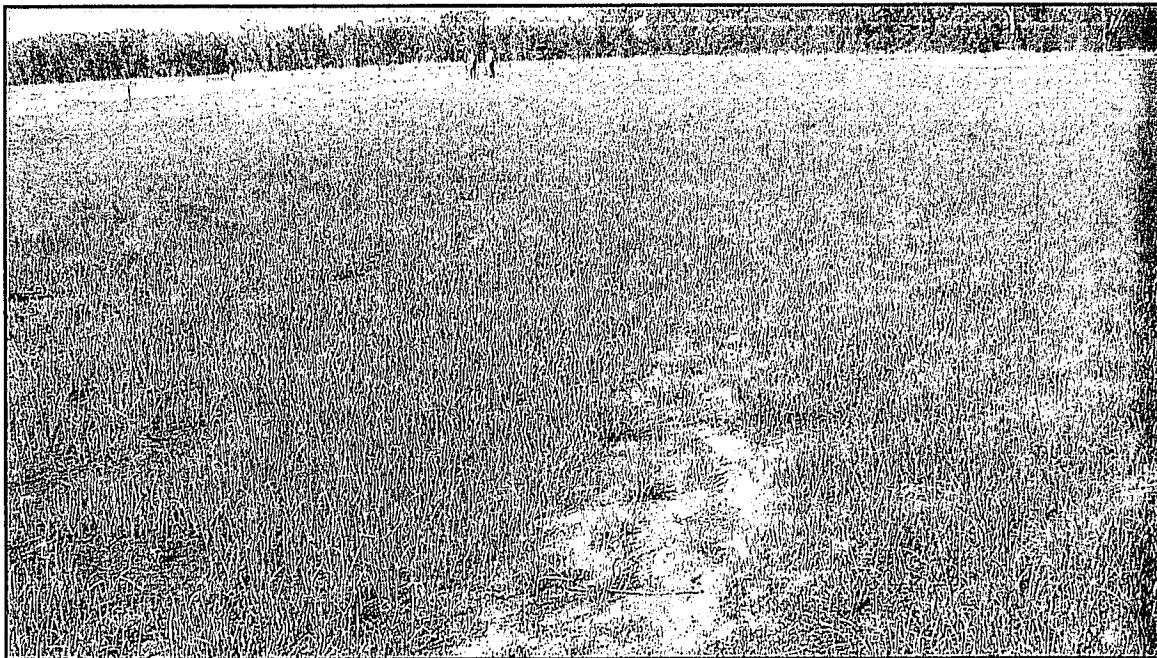
Photograph SFL2009-4 – View looking west of differential settlement/ponding in east central portion of landfill (11 May 09).

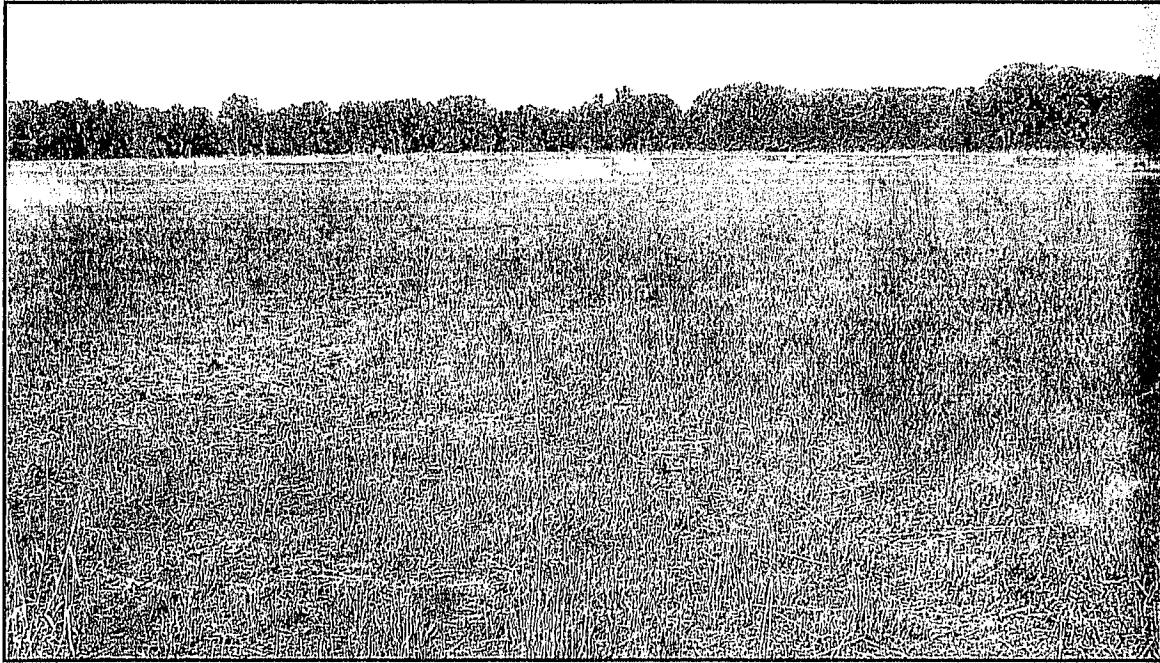
Photograph SFL2009-5 – View looking west of differential settlement in central portion of east half of landfill (11 May 09).

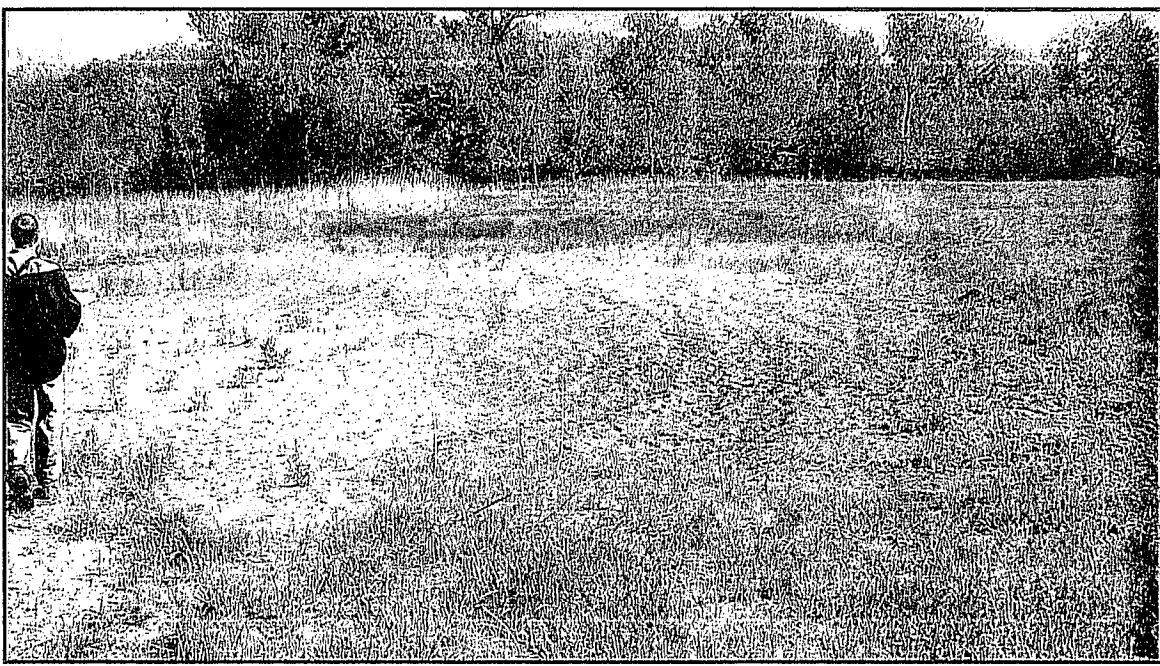
Photograph SFL2009-6 – View looking east of standing water in east central section of the landfill (11 May 09).

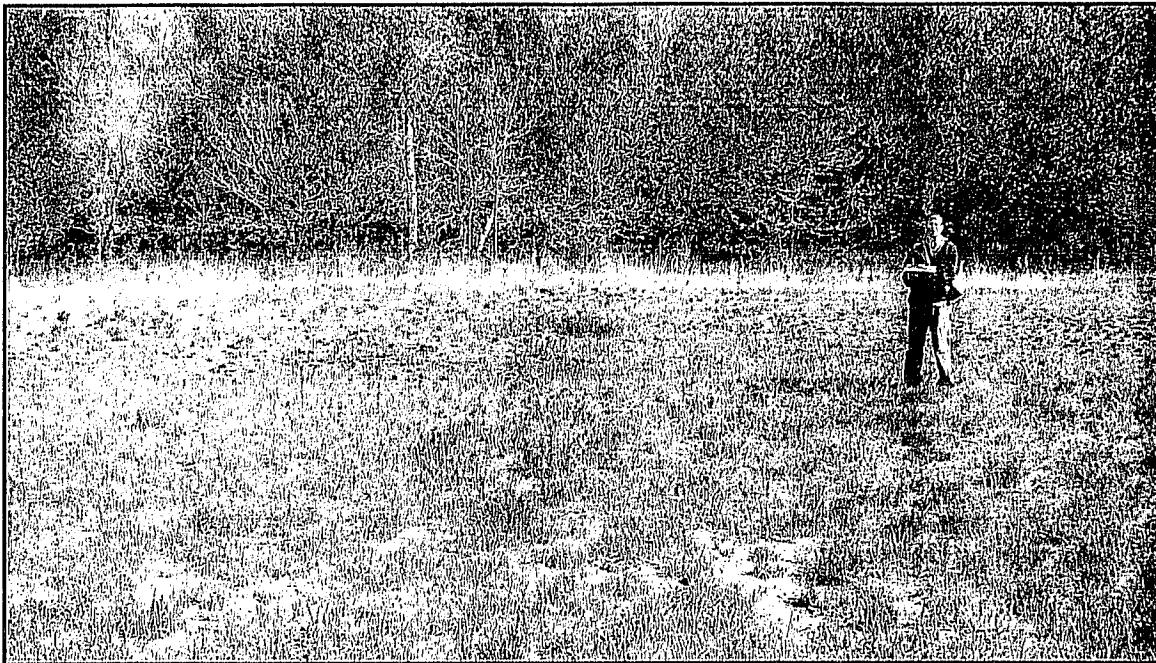
Photograph SFL2009-7 – Differential settlement/ponding at east central edge of landfill (11May 09).

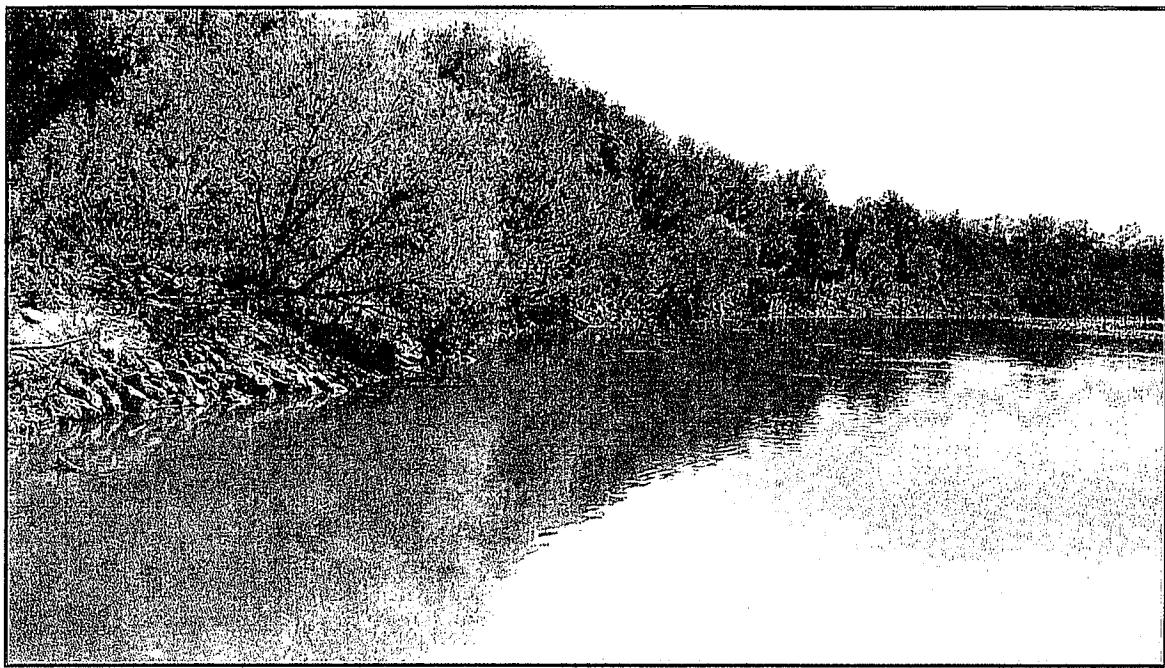
3.2.1 Observed Condition - The bank stabilization structure is performing as designed. There is no evidence of erosion, sloughing, or scour of the revetment. The current condition of the rock revetment is shown in photographs SFL2009-9 and SFL2009-10 at Attachment A.

Photograph SFL2009-9 – Upstream reach of rock revetment (11May 09).

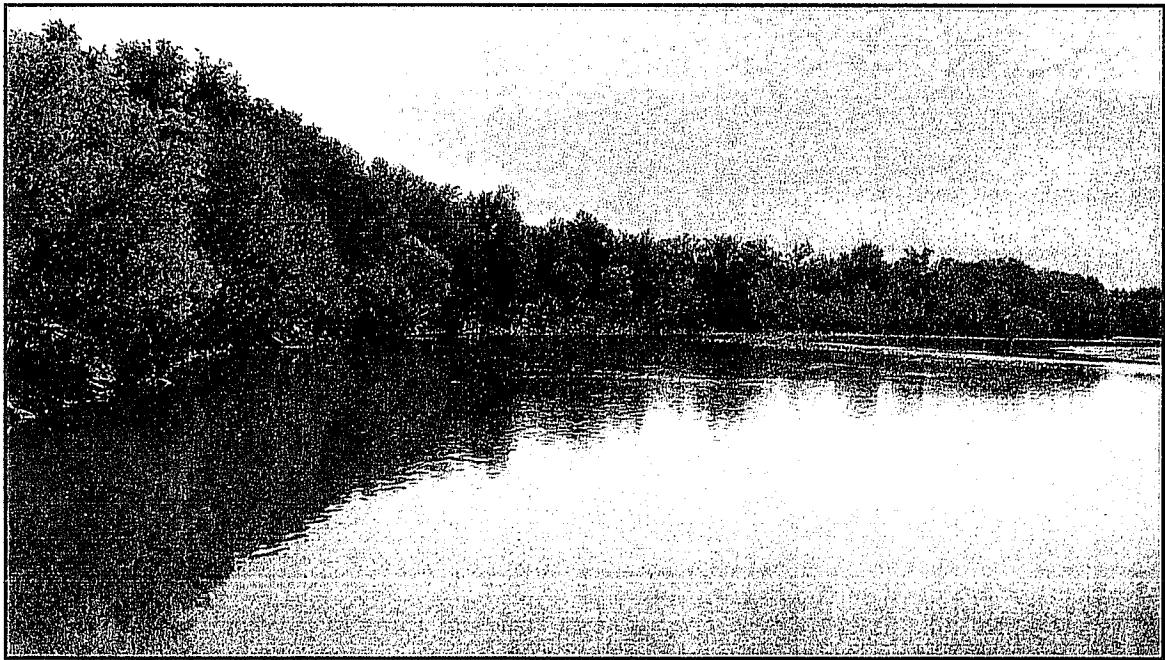
Photograph SFL2009-10 – Downstream reach of rock revetment (11-May-09).

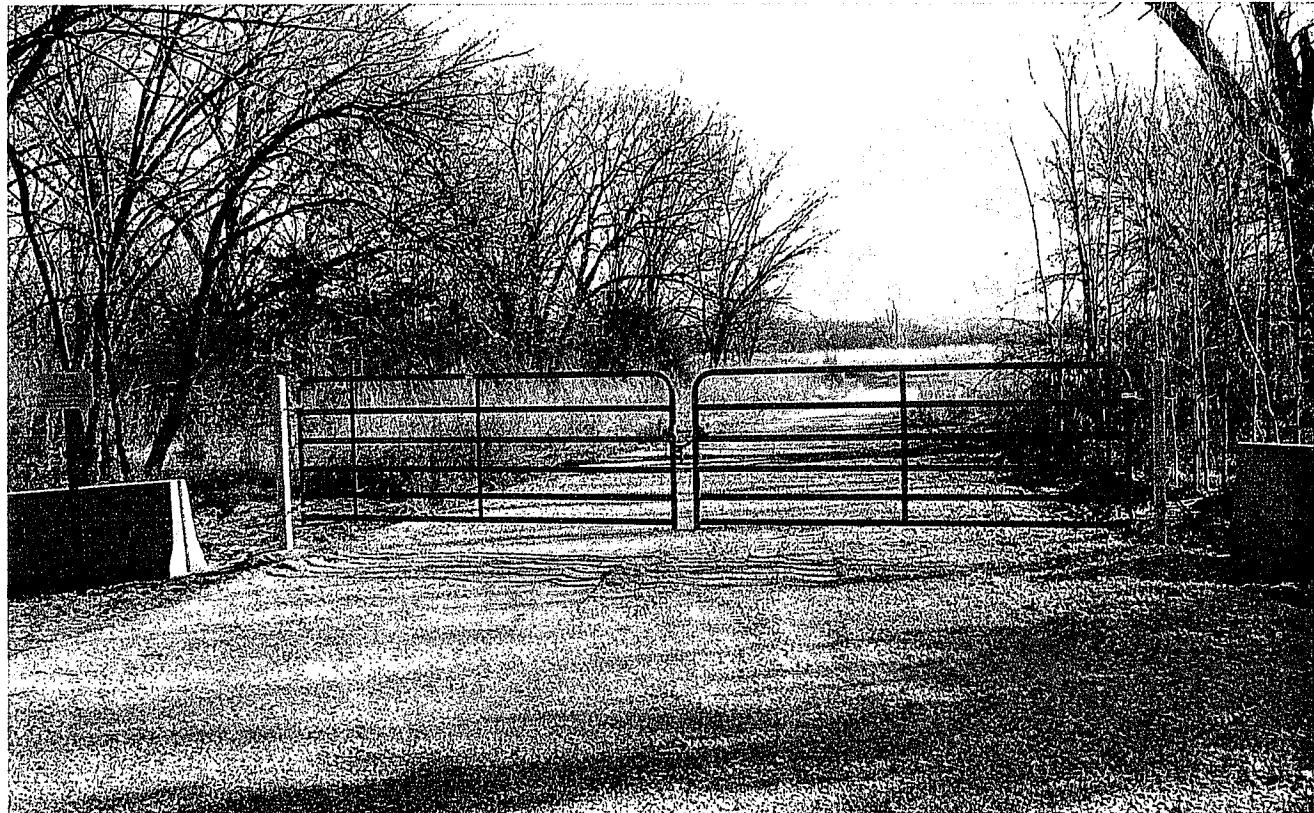
Photograph of SFL (30 November 2009)-1: View looking south at the entrance to the Southwest Funston Landfill-site access controls replaced/updated in September-October 2009: Warning Signage, Locked Gates, and Concrete Barriers

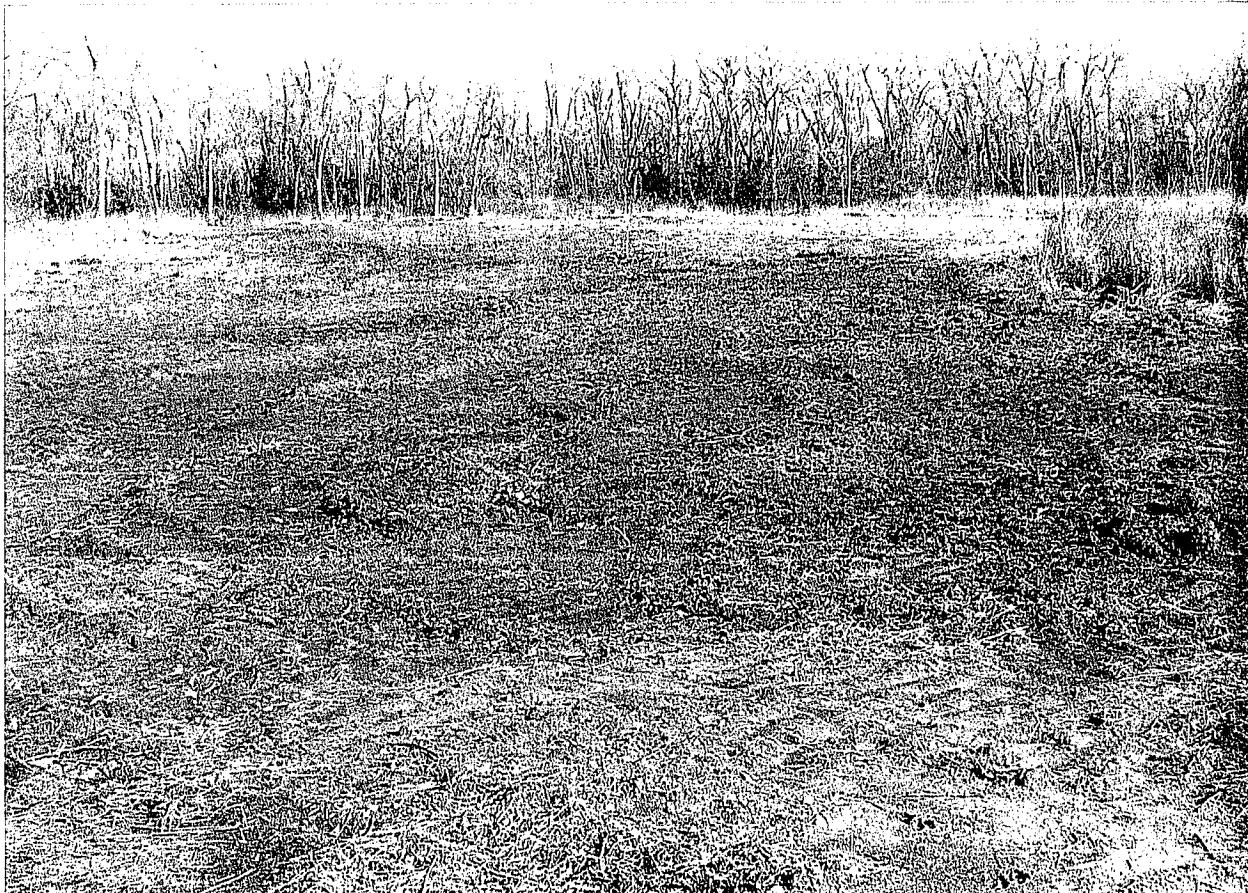
Photograph of SFL (23 November 2009)-2: Landfill cover repair of differential settlement/ponding in northeast quadrant of the Southwest Funston Landfill in September –October 2009

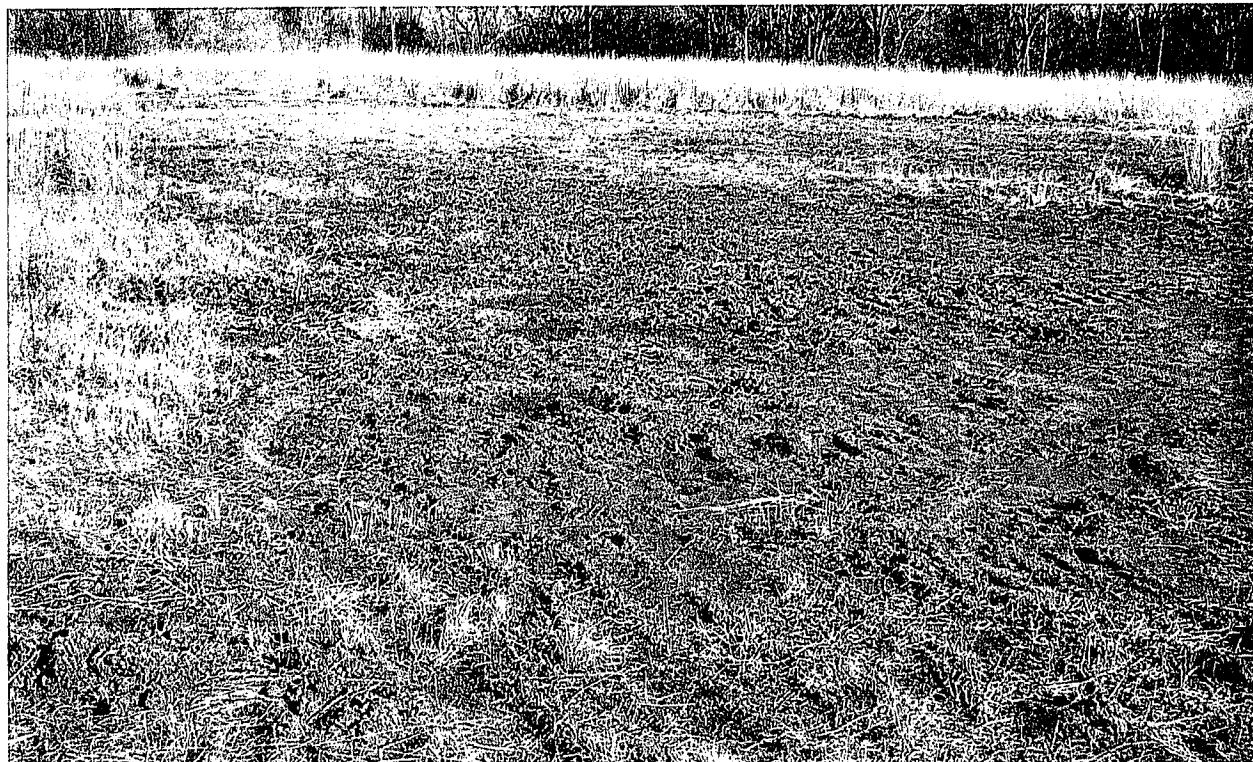
Photograph of SFL (30 November 2009)-3: Landfill cover repair of differential settlement/ponding at east central edge of landfill

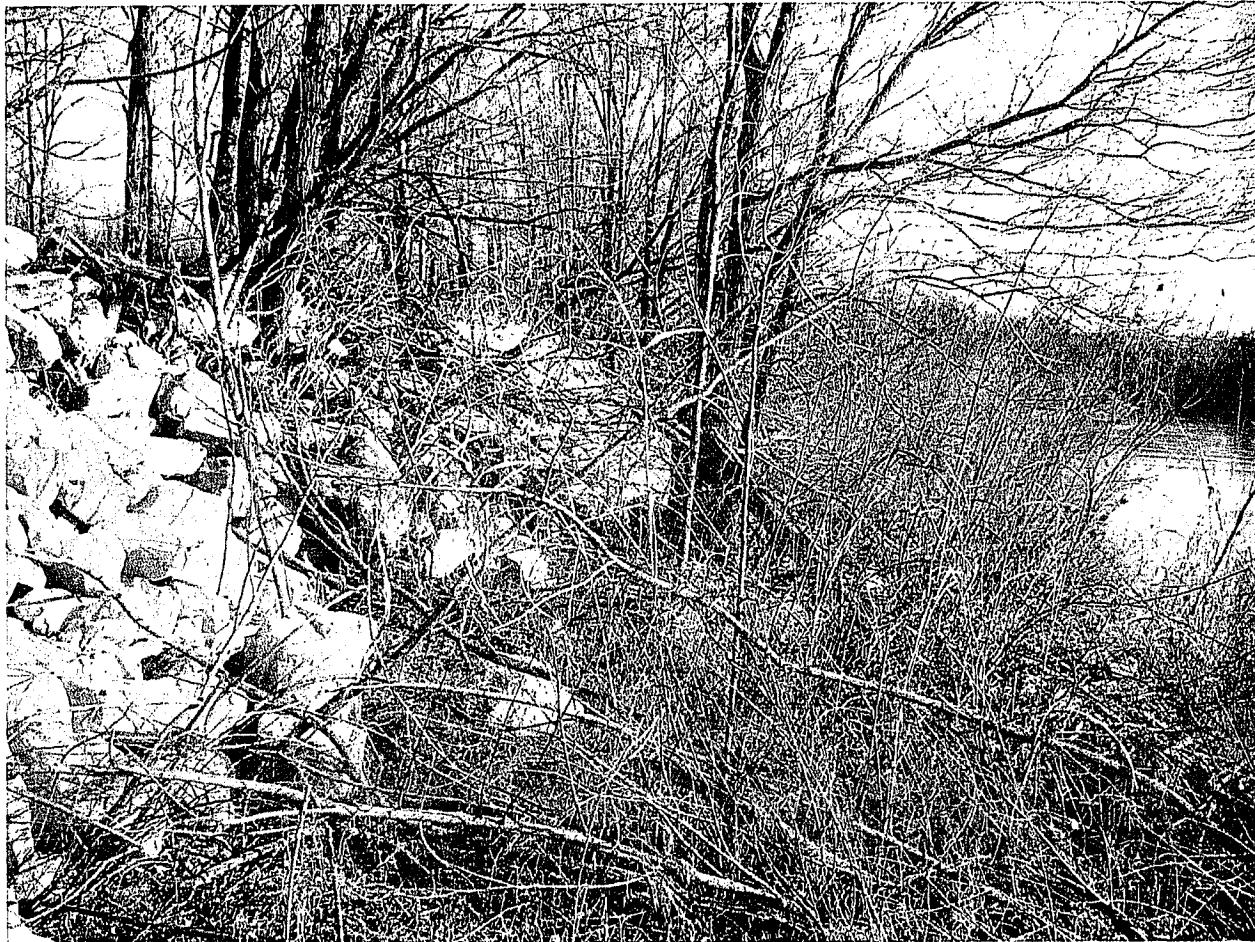
Photograph of SFL (23 November 2009)-4: Rock armoring of the landfill upper riverbank slope of rubble areas to cover slate, tar material, and 4% Chrysotile asbestos tiles in October 2009

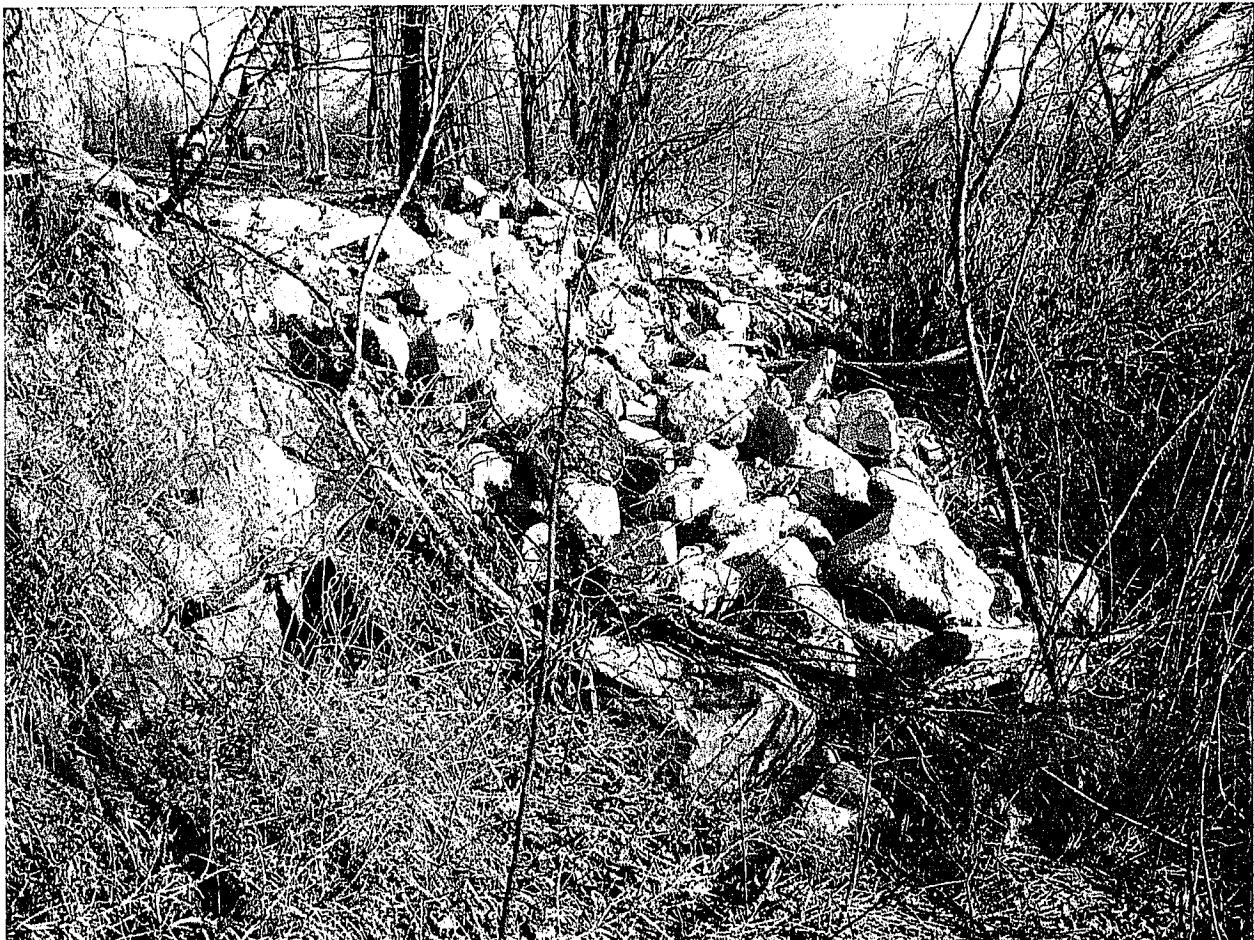
Photograph of SFL (23 November 2009)-5: Two-hundred-fifty (250) linear feet of rock armoring of the landfill-upper riverbank slope to cover the exposed rubble of slate, tar materials, and 4% Chrysotile asbestos tiles in October 2009
