**FINAL REPORT FOR THE RAPID RESPONSE  
REPLACEMENT OF SANITARY SEWER LINE  
BUILDING 180-183  
AT FORT RILEY, KANSAS**

**CONTRACT NO. DACW45-94-D-005  
DELIVERY ORDER NO. 3**

**OHM Remediation Services Corp.  
Midwest Region**

September 8, 1994  
Project 15747

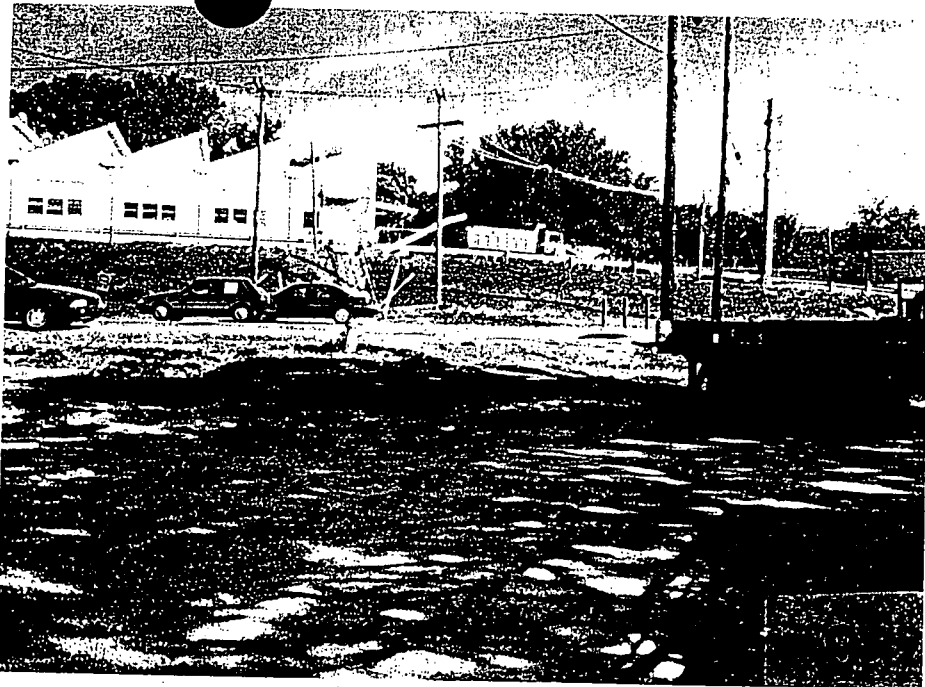
FINAL BACKFILL - END OF PROJECT

Upon completion of the sewer line installation and acceptance by the USACE field representative, the backfilling of the excavation was completed. Prior to the final backfill, after a strong evening rain, settling of backfill material (primarily excavated soils) was observed. More fill was added to these areas to restore them to grade, and minimal compaction was performed. Additional gravel was also added in the area of Custer Avenue. Compaction of the excavation was performed as directed by the USACE on-site representative (OSR).

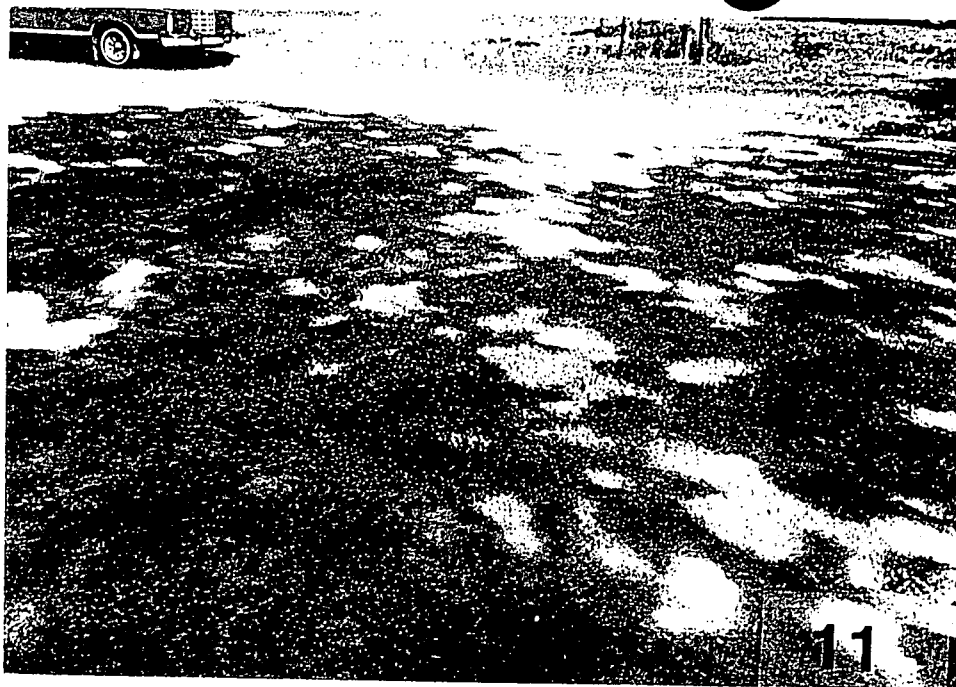
11

FINAL BACKFILL - END OF PROJECT

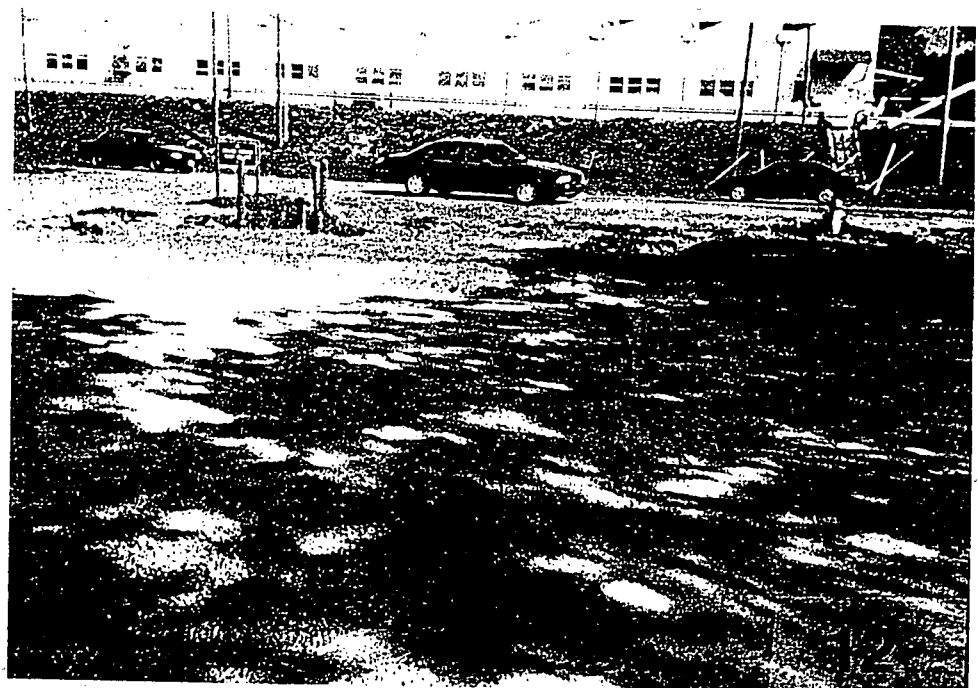
FINAL BACKFILL - END OF PROJECT

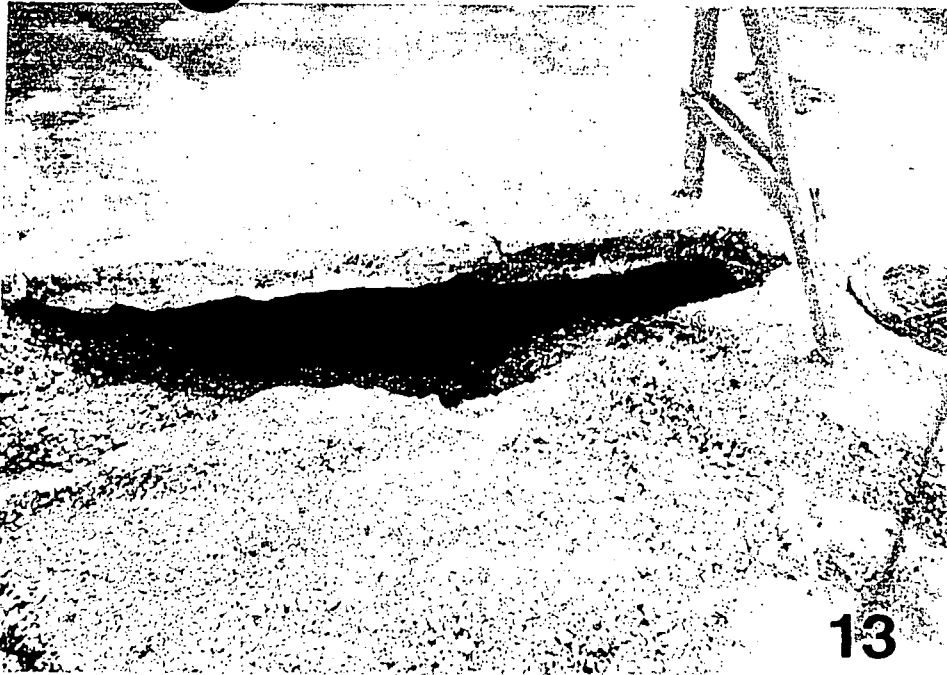
13

WASHOUT NEAR LOWER MANHOLE - NEAR END OF PROJECT

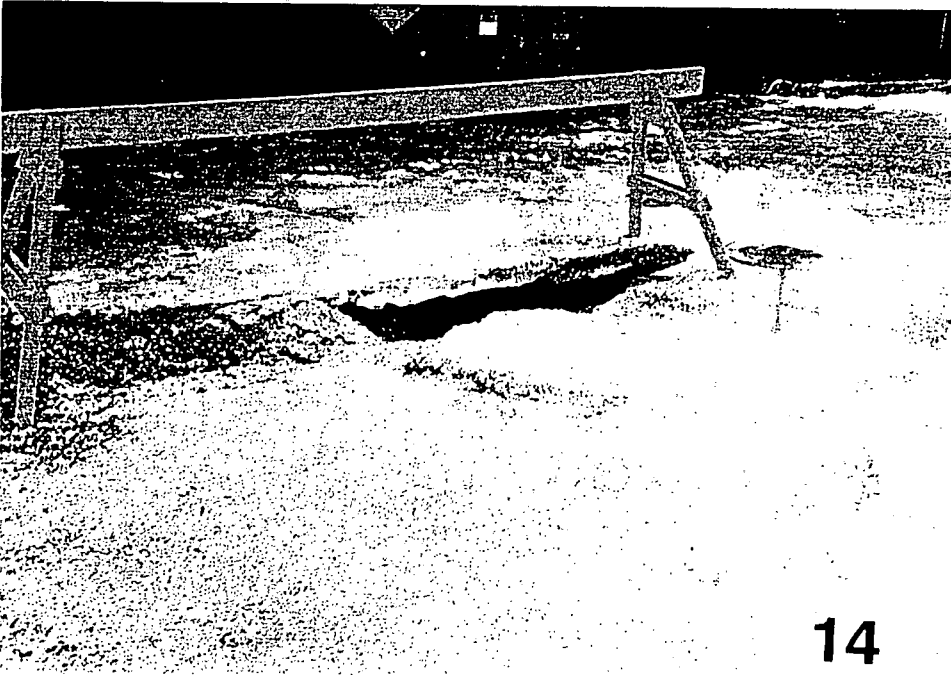
14

WASHOUT NEAR LOWER MANHOLE - NEAR END OF PROJECT

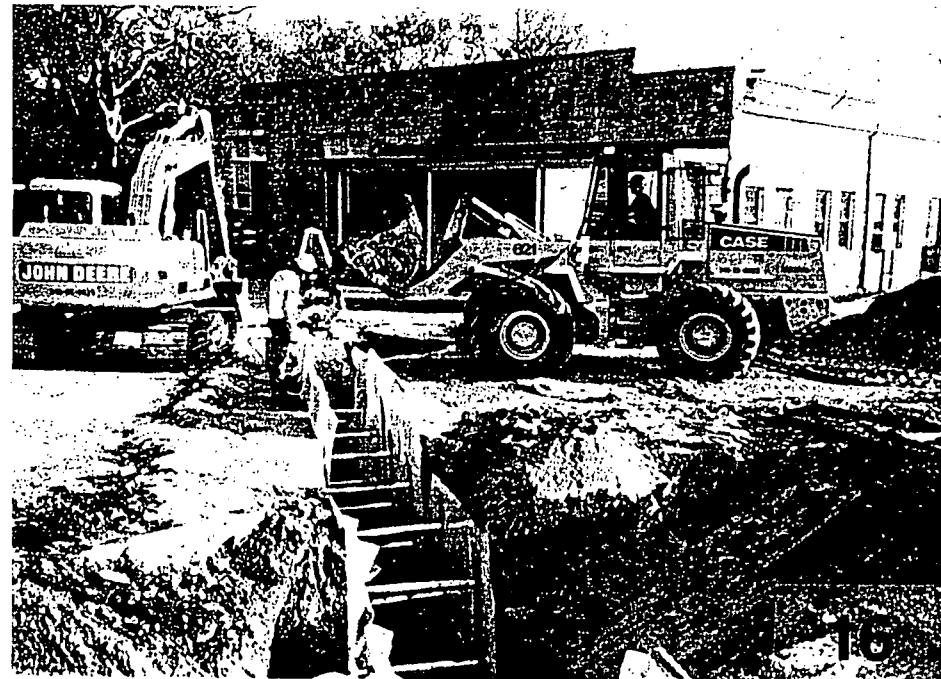
16

COMMENCEMENT OF TRENCH BACKFILL - NEAR END OF PROJECT

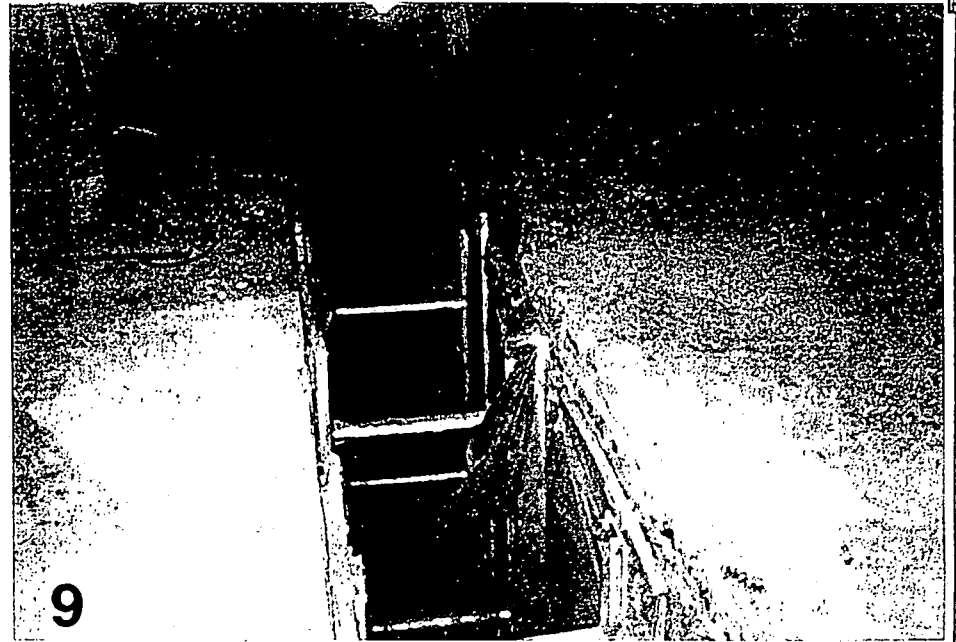
EXCAVATION AND SHORING - MIDDLE OF PROJECT

Upon completion of the shoring operation, the new sewer line was installed. The new sewer line was installed in accordance with Appendix J, Environmental Engineering Instructions in the work plan. A leakage test was not required per the direction of the USACE.

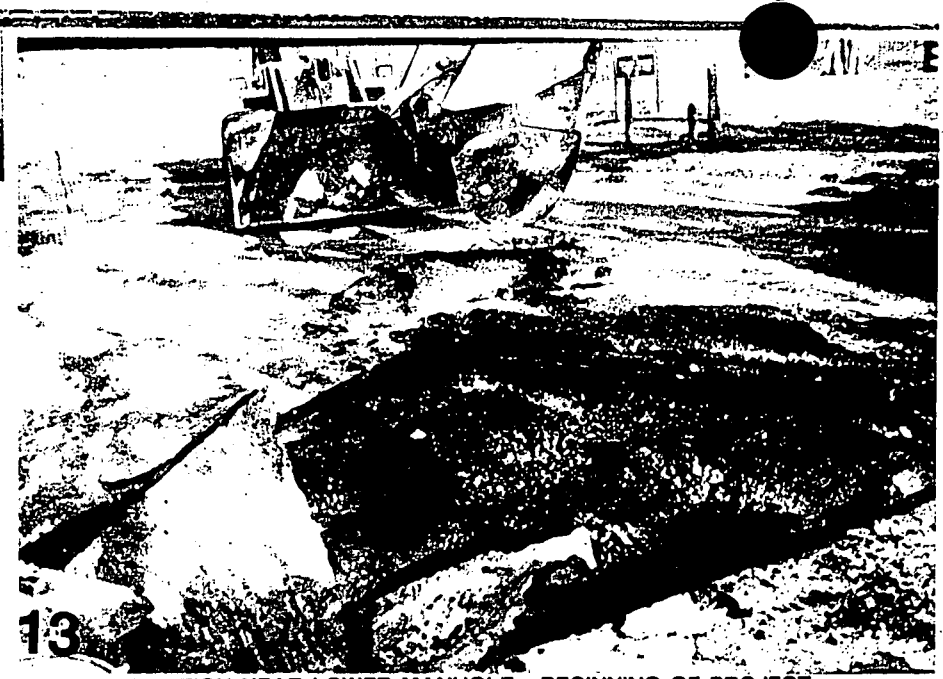
EXCAVATION NEAR LOWER MANHOLE - BEGINNING OF PROJECT

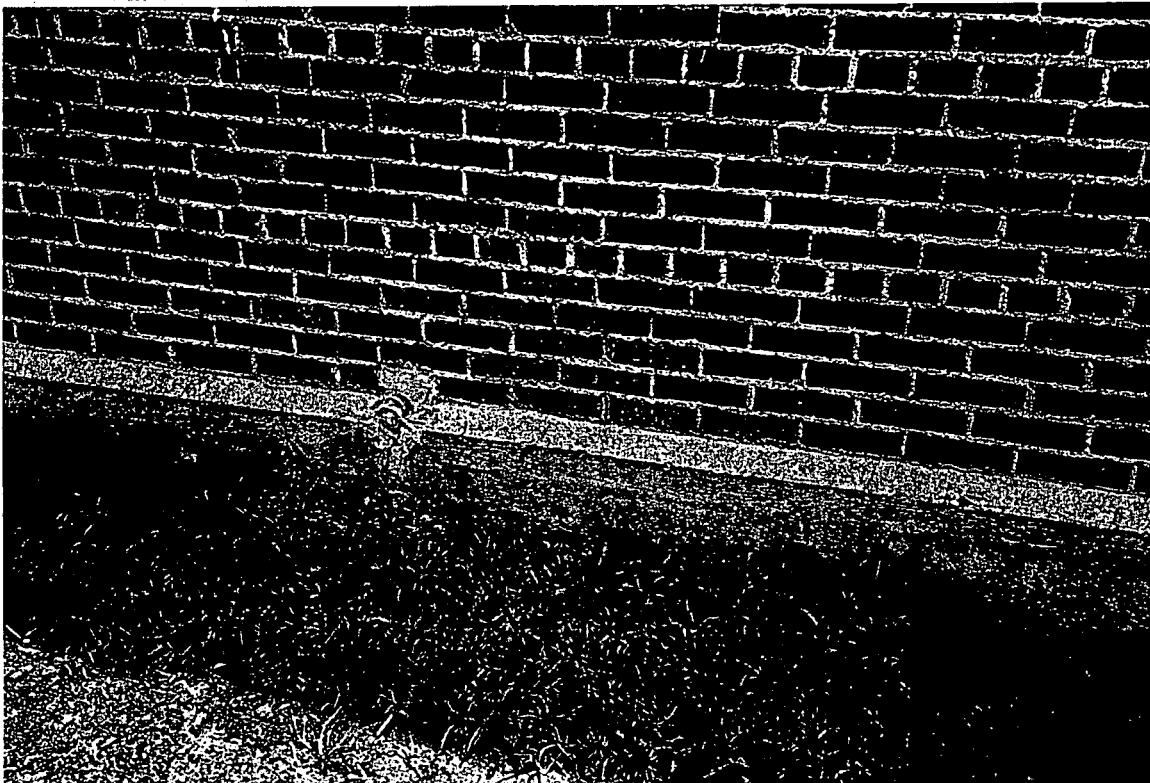
2

CAPPED VENT LINES - END OF PROJECT

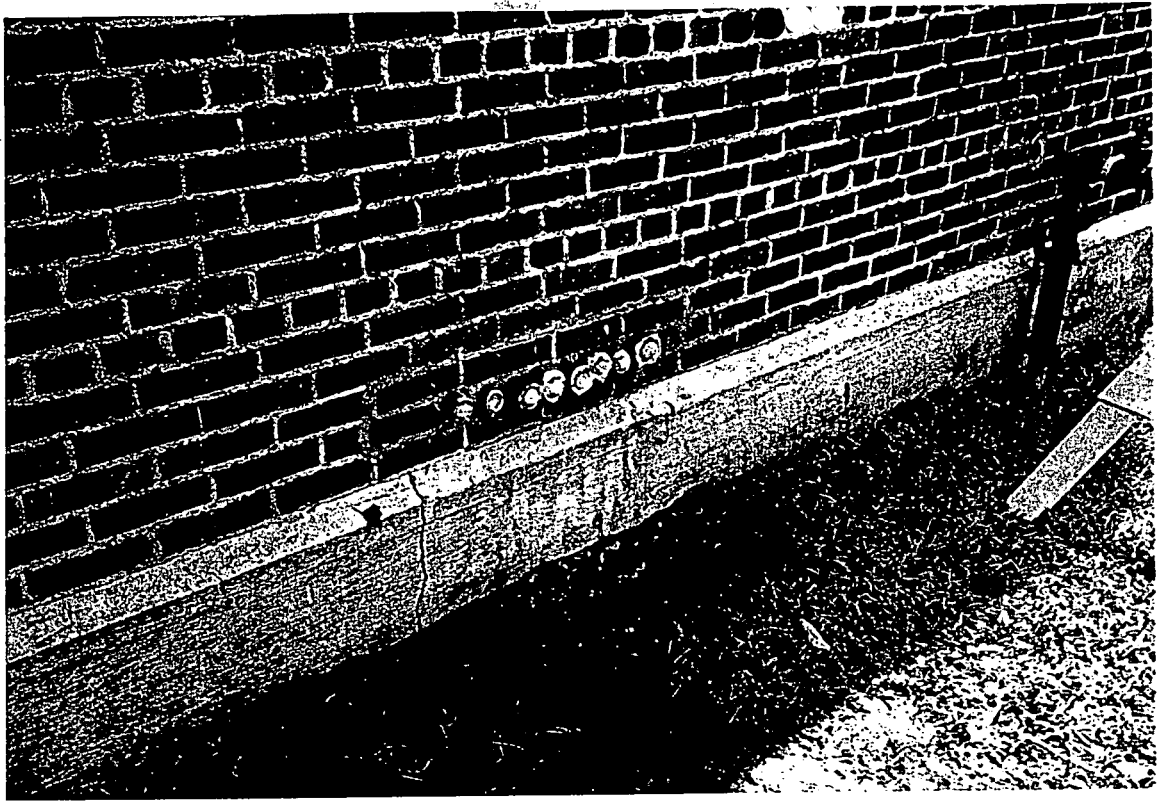
3

CAPPED VENT LINES - END OF PROJECT

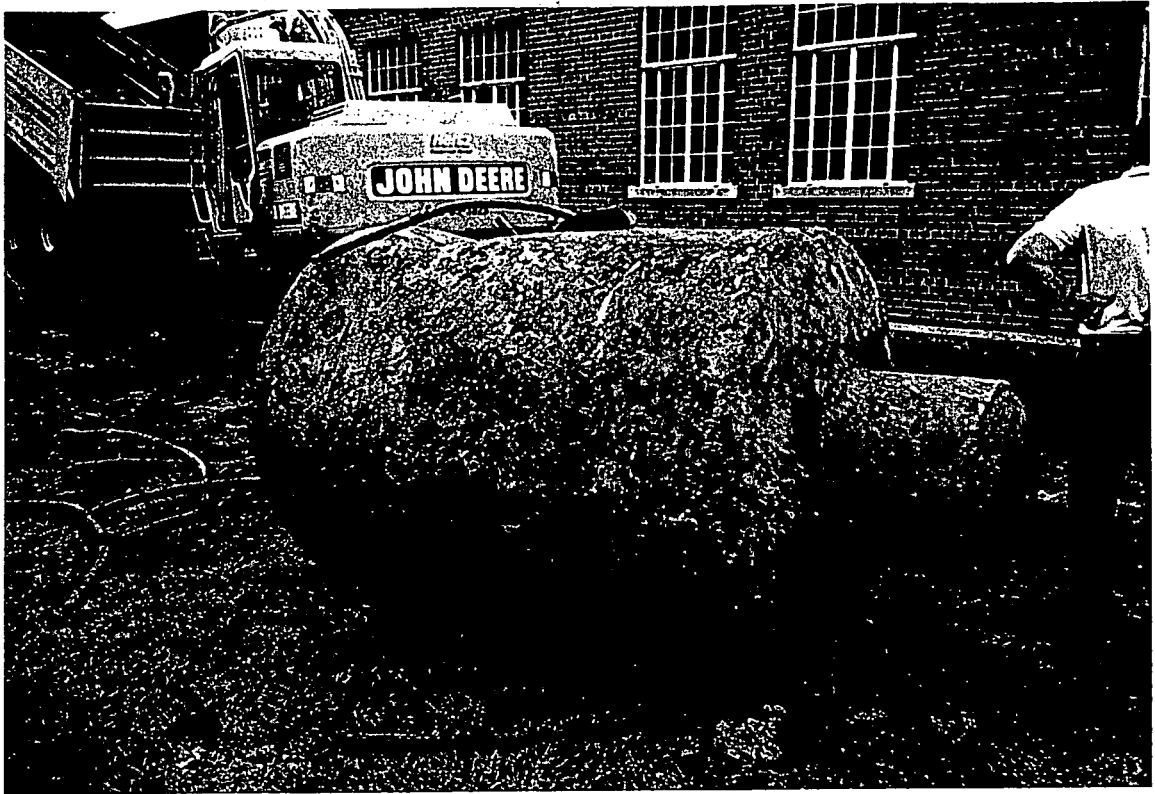
LARGER UST - NEAR END OF PROJECT

During the replacement of the sanitary sewer line, the three USTs were located by exposing their tops. During the week of July 11, 1994 a small crew returned to remove the USTs. After commencement of the excavation to expose the tanks, it was quickly discovered that one tank was significantly larger than expected. The larger tank was vertically placed and was approximately 7 feet across and approximately 17 feet deep. Because of the larger tank's proximity to Building 180 and a power pole, Fort Riley personnel decided to abandon that tank in place.

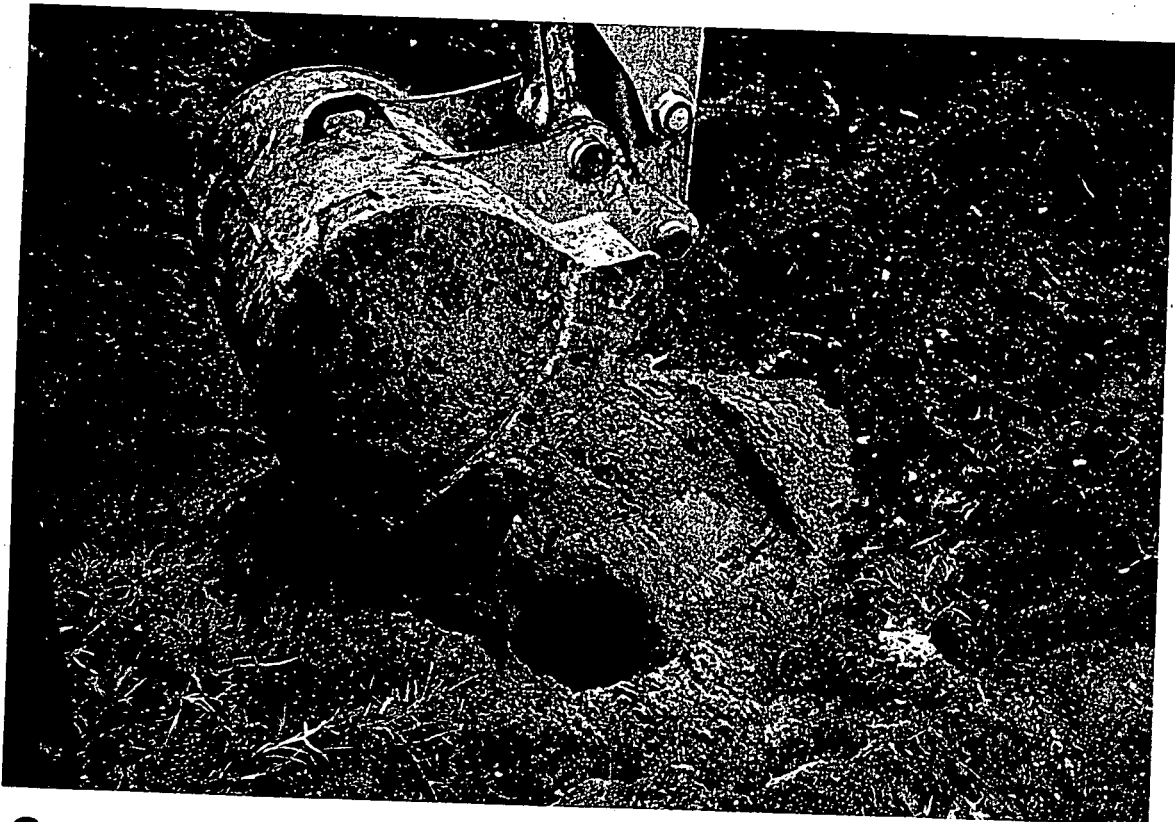
8

IN-PLACE ABANDONMENT OF LARGE UST - NEAR END OF PROJECT

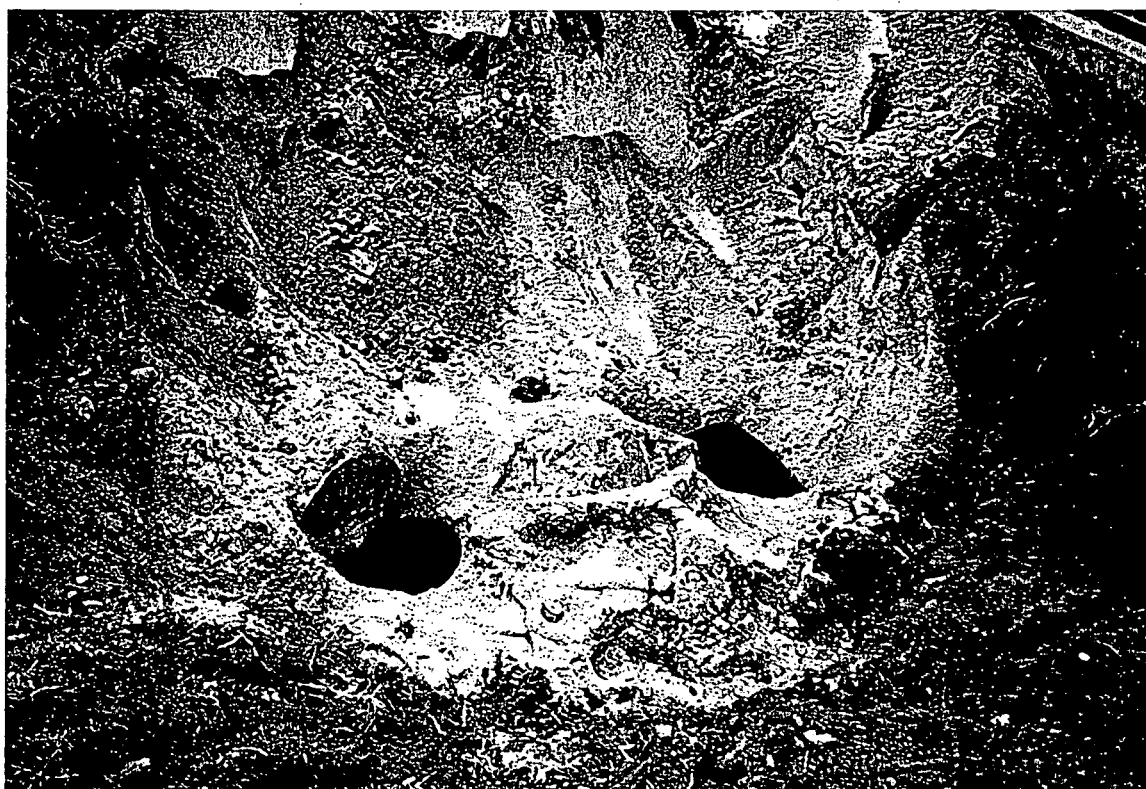
10

IN-PLACE ABANDONMENT OF LARGE UST - NEAR END OF PROJECT

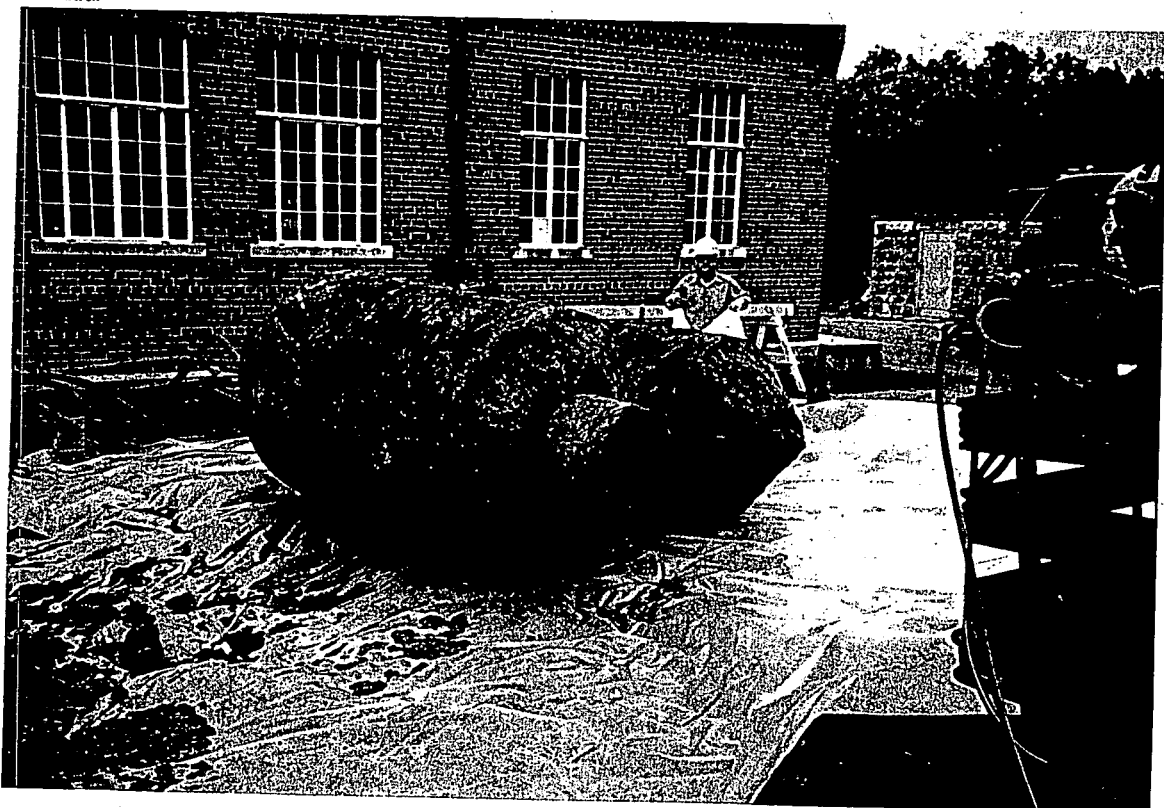
**14**

EXCAVATED USTs AND PIPING - NEAR END OF PROJECT
