*Draft Final*  
*Remedial Action Completion Report*

**Southwest Funston Landfill Site, OU001**  
**Fort Riley, Kansas**  
**December 2009**

Subject: Remedial Action Completion Report (RACR), Southwest Funston Landfill Site, OU001

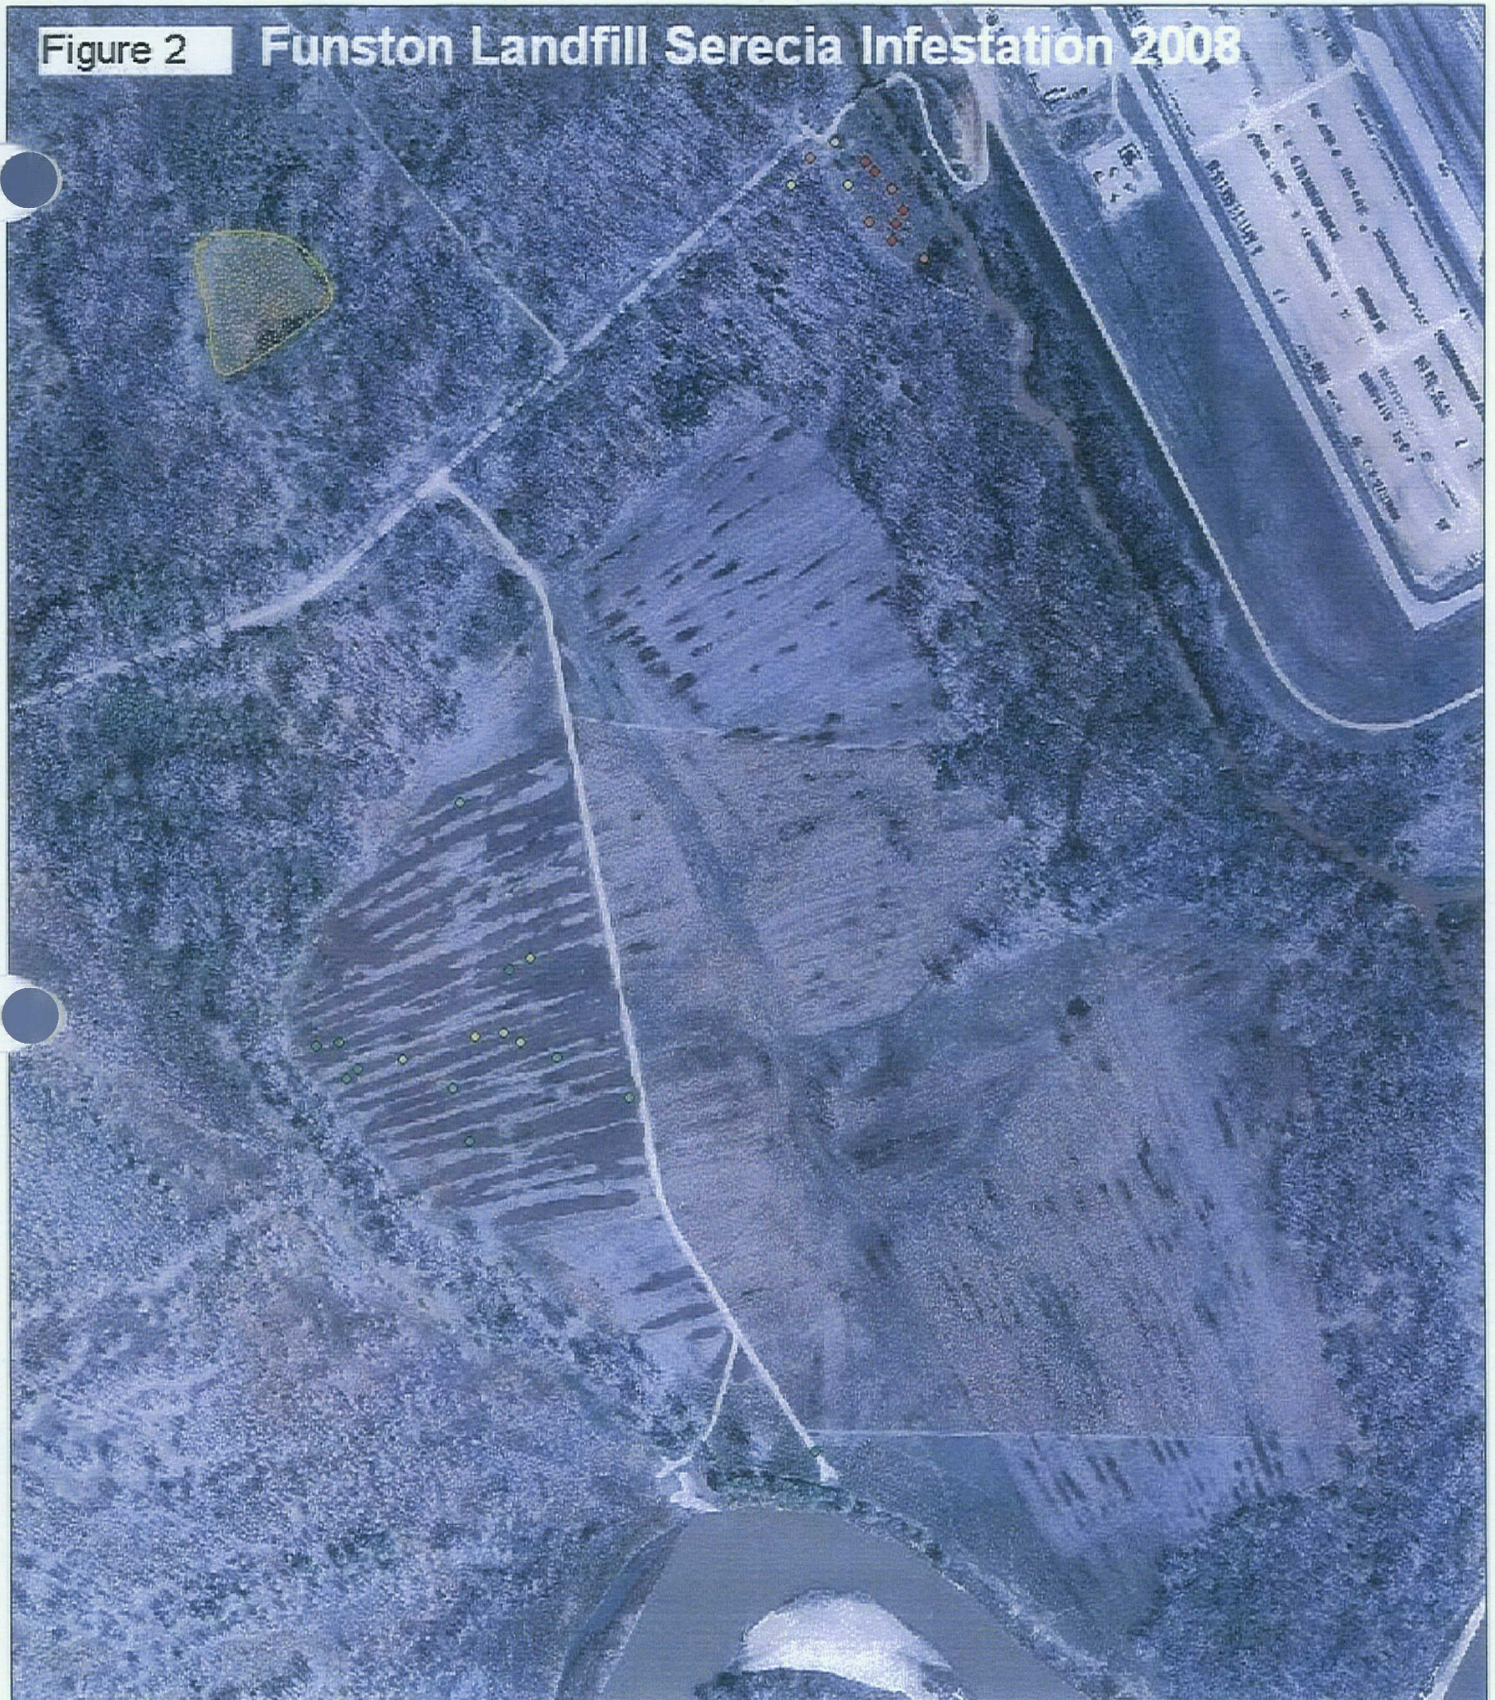
**Figure 2 Funston Landfill Serecia Infestation 2008**

<b>Plants Per Point</b>		Heavy Infestation	9 Pts (32%)	<b>28 Total Data Points</b>	Food Plots	
1 - 5	16 - 20	Moderate Infestation	4 Pts (14%)		Fire Breaks	
6 - 9	21 - 30	Light Infestation	15 Pts (54%)	0 40 80 160 240		
10 - 15	31 - 50	Treatment	0 Pts (0%)	Meters

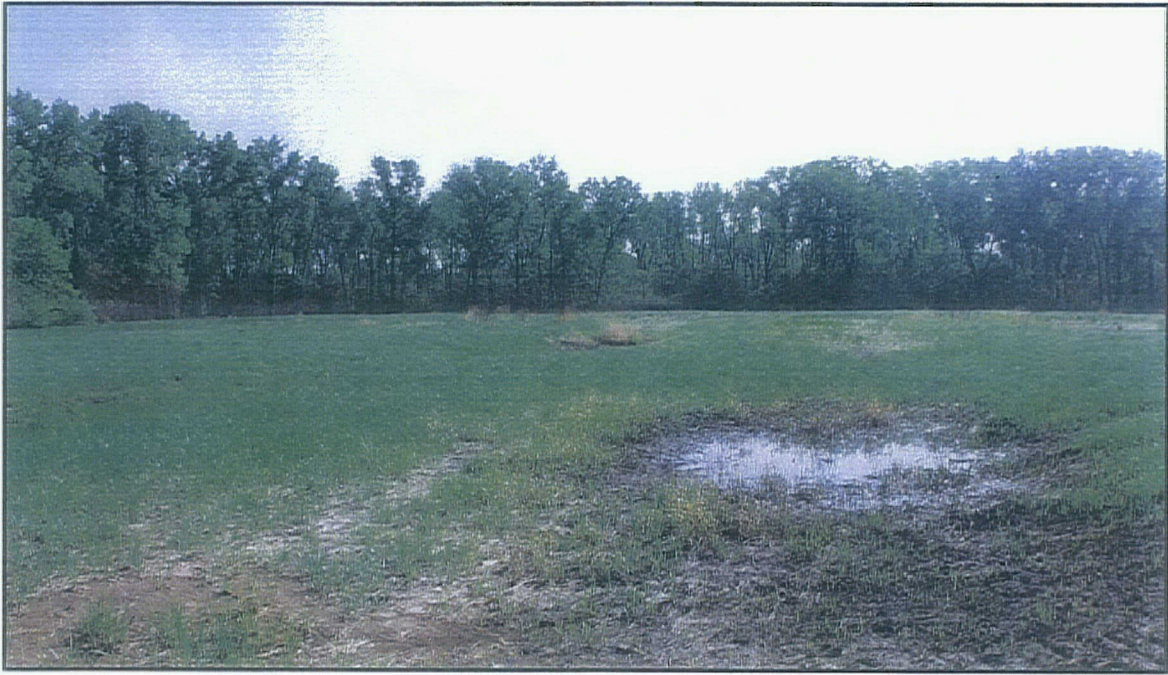
Photograph SFL2009-1 – View looking east of differential settlement/ponding in northeast quadrant of landfill (11May 09).

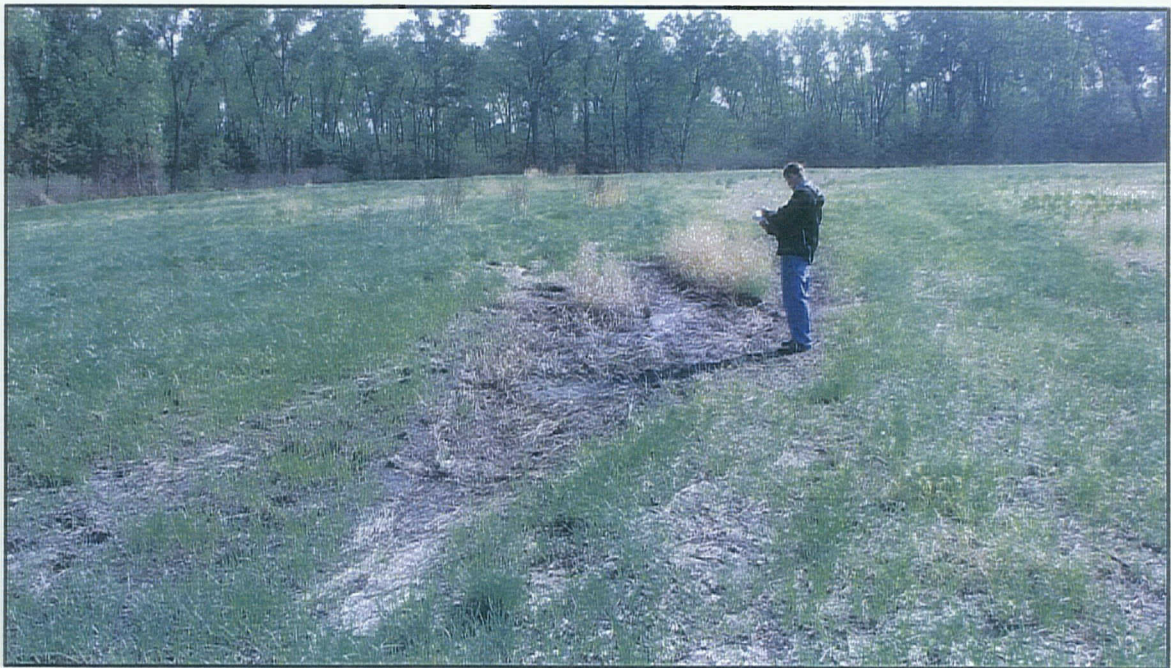
Photograph SFL2009-2 – View looking east of standing water in northeast quadrant of landfill (11 May 09).

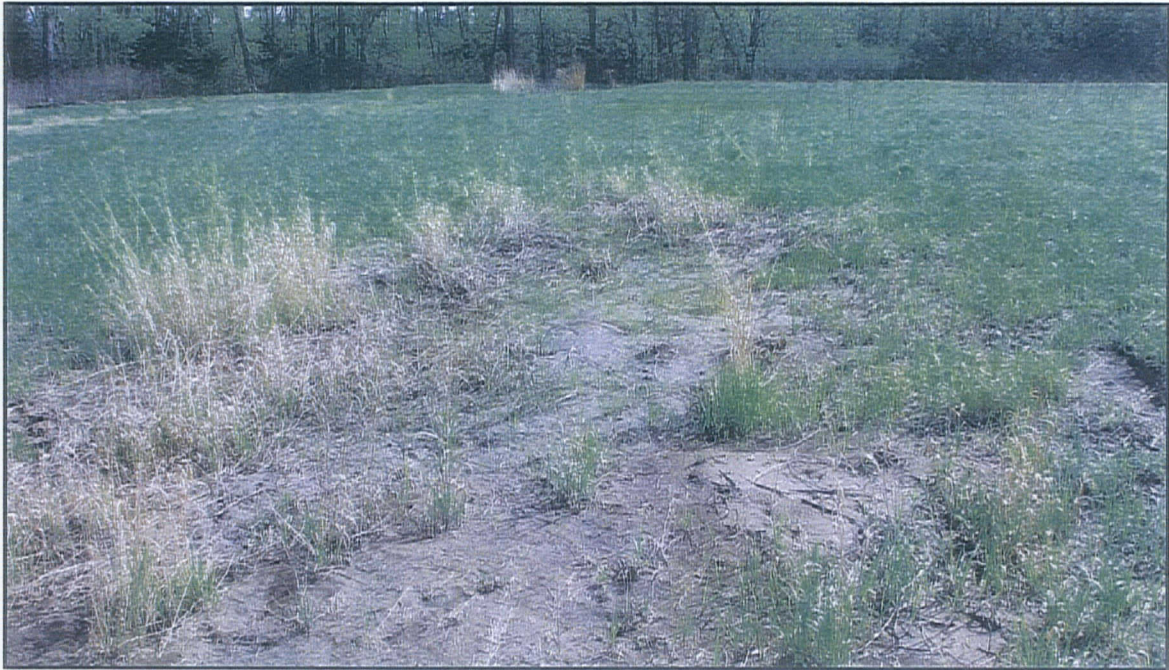
Photograph SFL2009-3 – View looking east at newly repaired area in northeast quadrant of landfill (11 May 09).

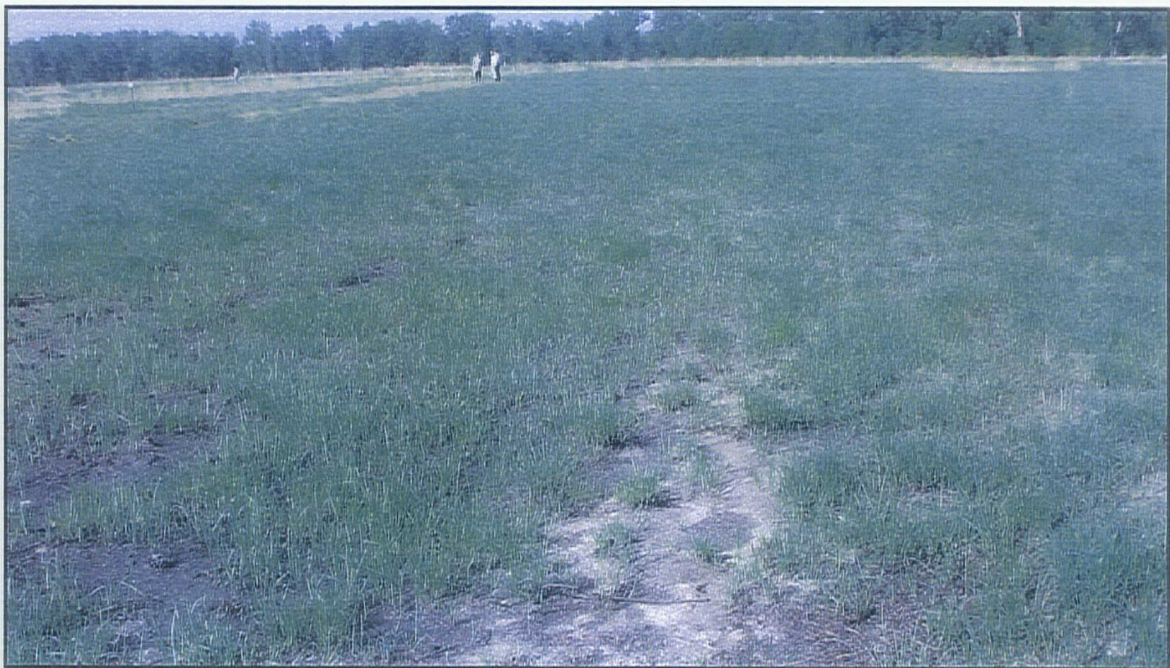
Photograph SFL2009-4 – View looking west of differential settlement/ponding in east central portion of landfill (11 May 09).

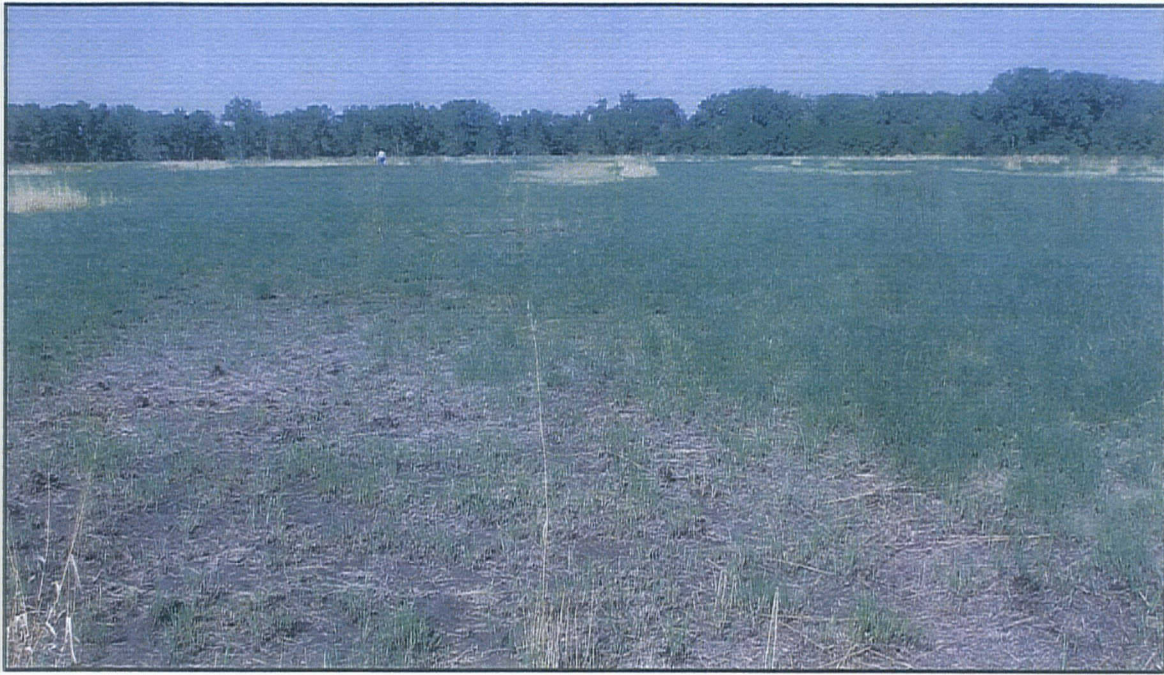
Photograph SFL2009-5 – View looking west of differential settlement in central portion of east half of landfill (11 May 09).

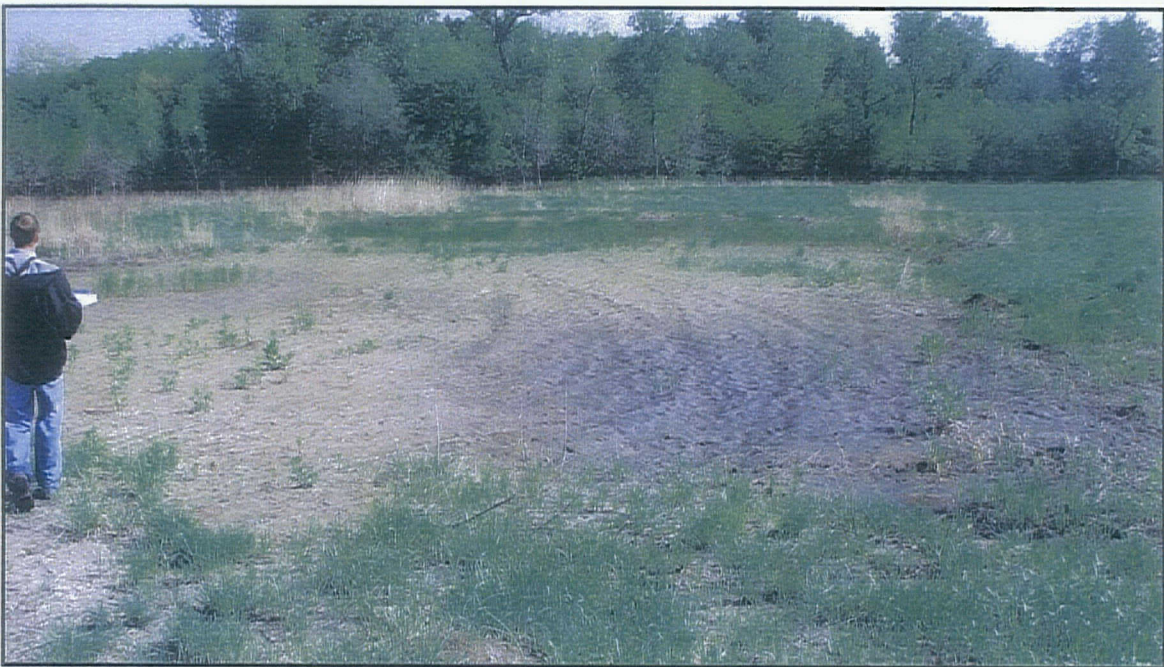
Photograph SFL2009-6 – View looking east of standing water in east central section of the landfill (11 May 09).

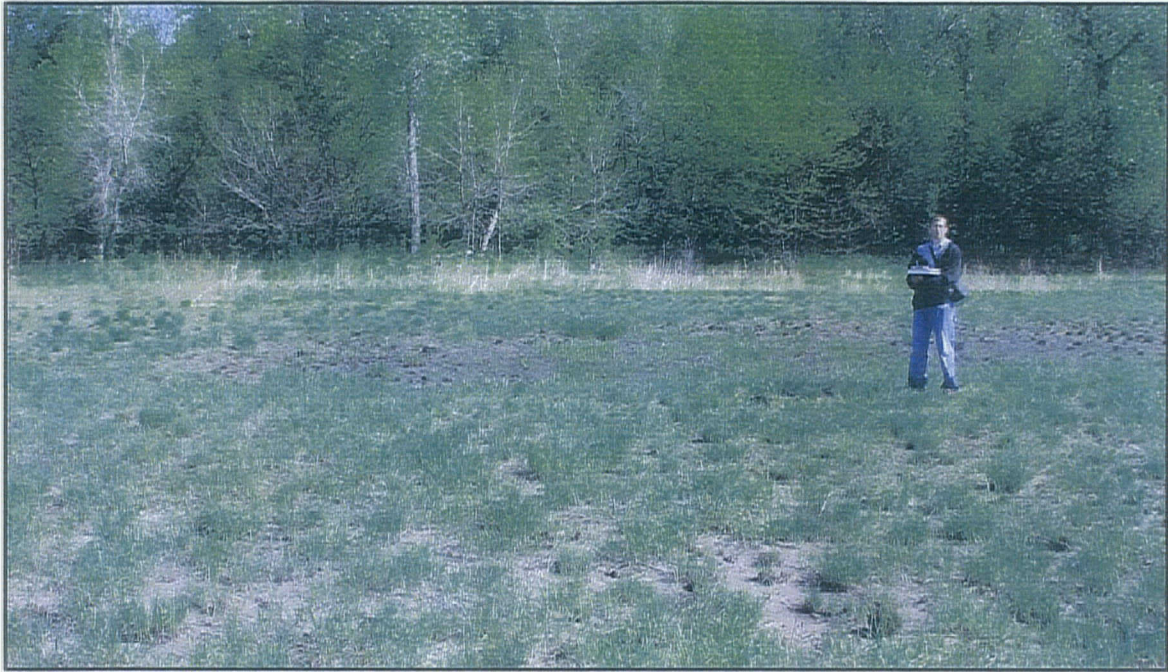
Photograph SFL2009-7 – Differential settlement/ponding at east central edge of landfill (11May 09).

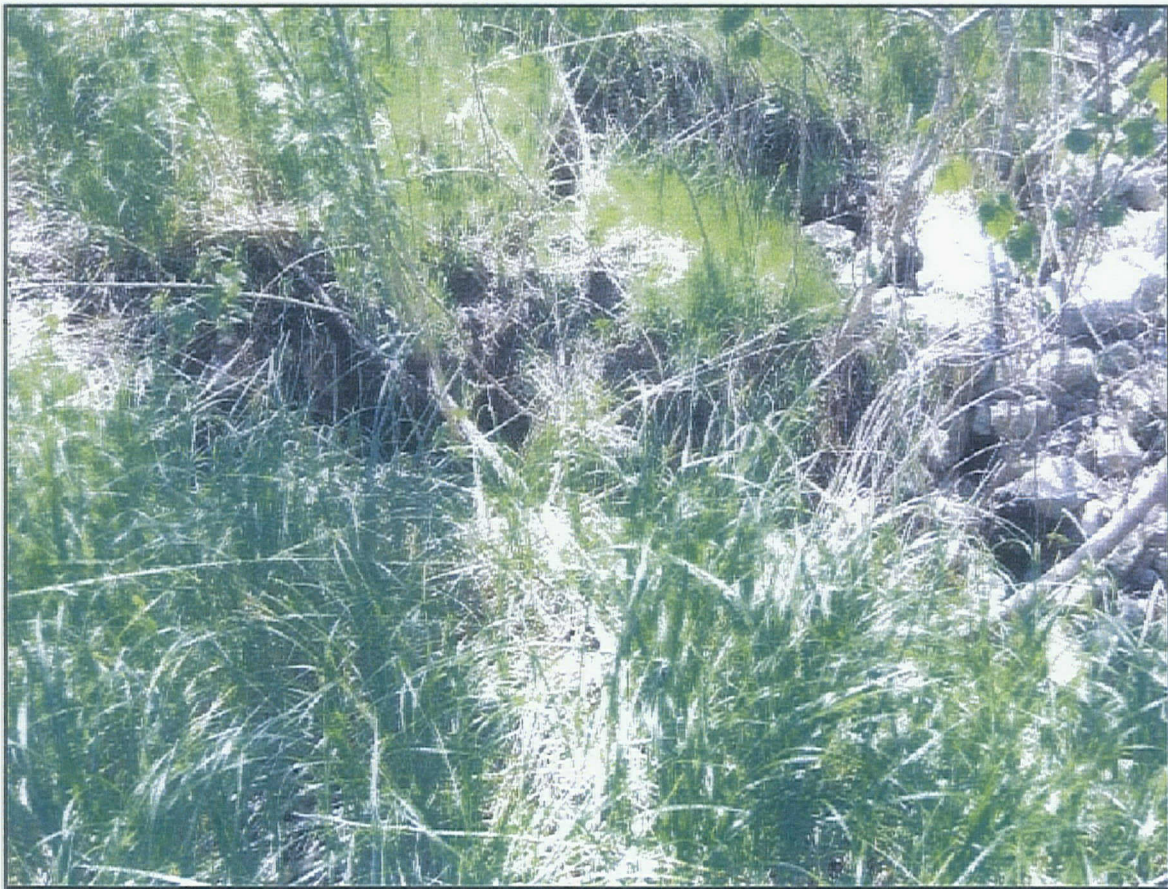
Photograph SFL2009-8 – Back cut erosion at downstream end of revetment (11 May 09).

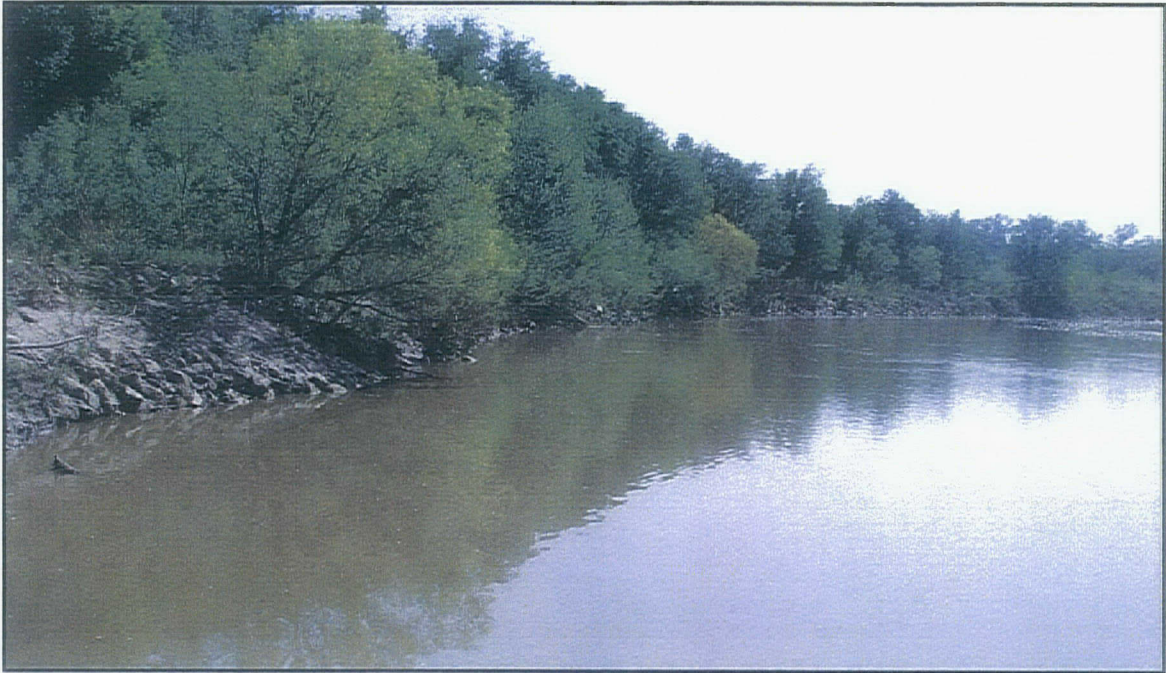
Photograph SFL2009-9 – Upstream reach of rock revetment (11May 09).

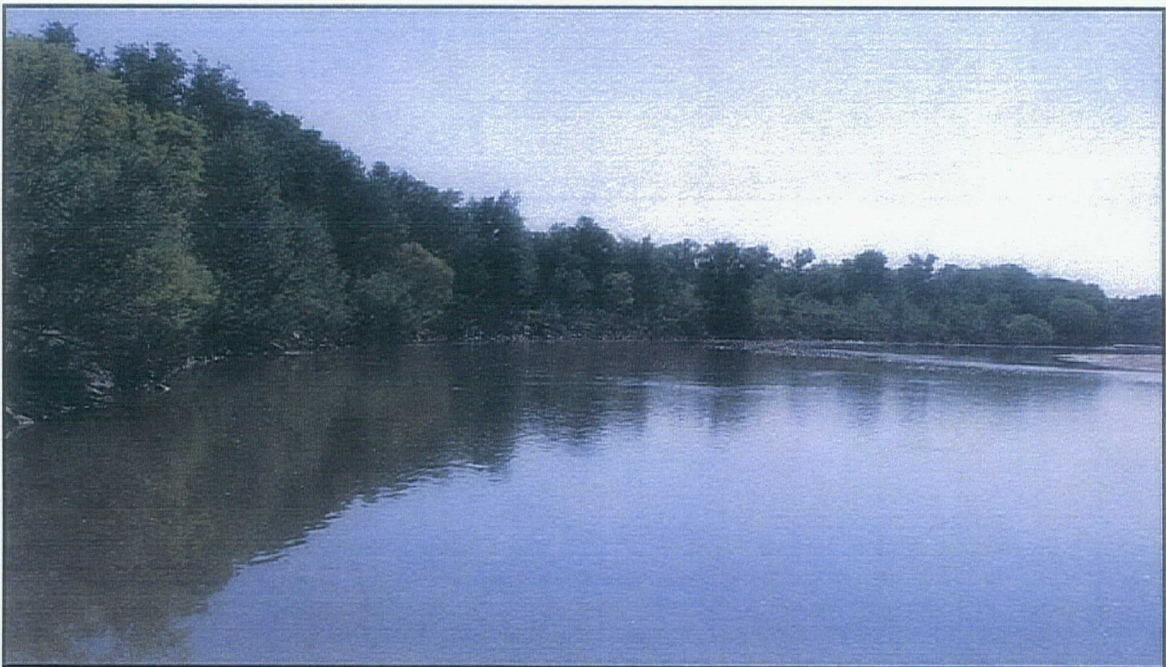
Photograph SFL2009-10 – Downstream reach of rock revetment (11 May 09).
