FINAL **PRELIMINARY ASSESSMENT** **AND SITE INSPECTION OF** **PER- AND** **POLYFLUOROALKYL** **SUBSTANCES**

Fort Riley, Kansas

January 2022

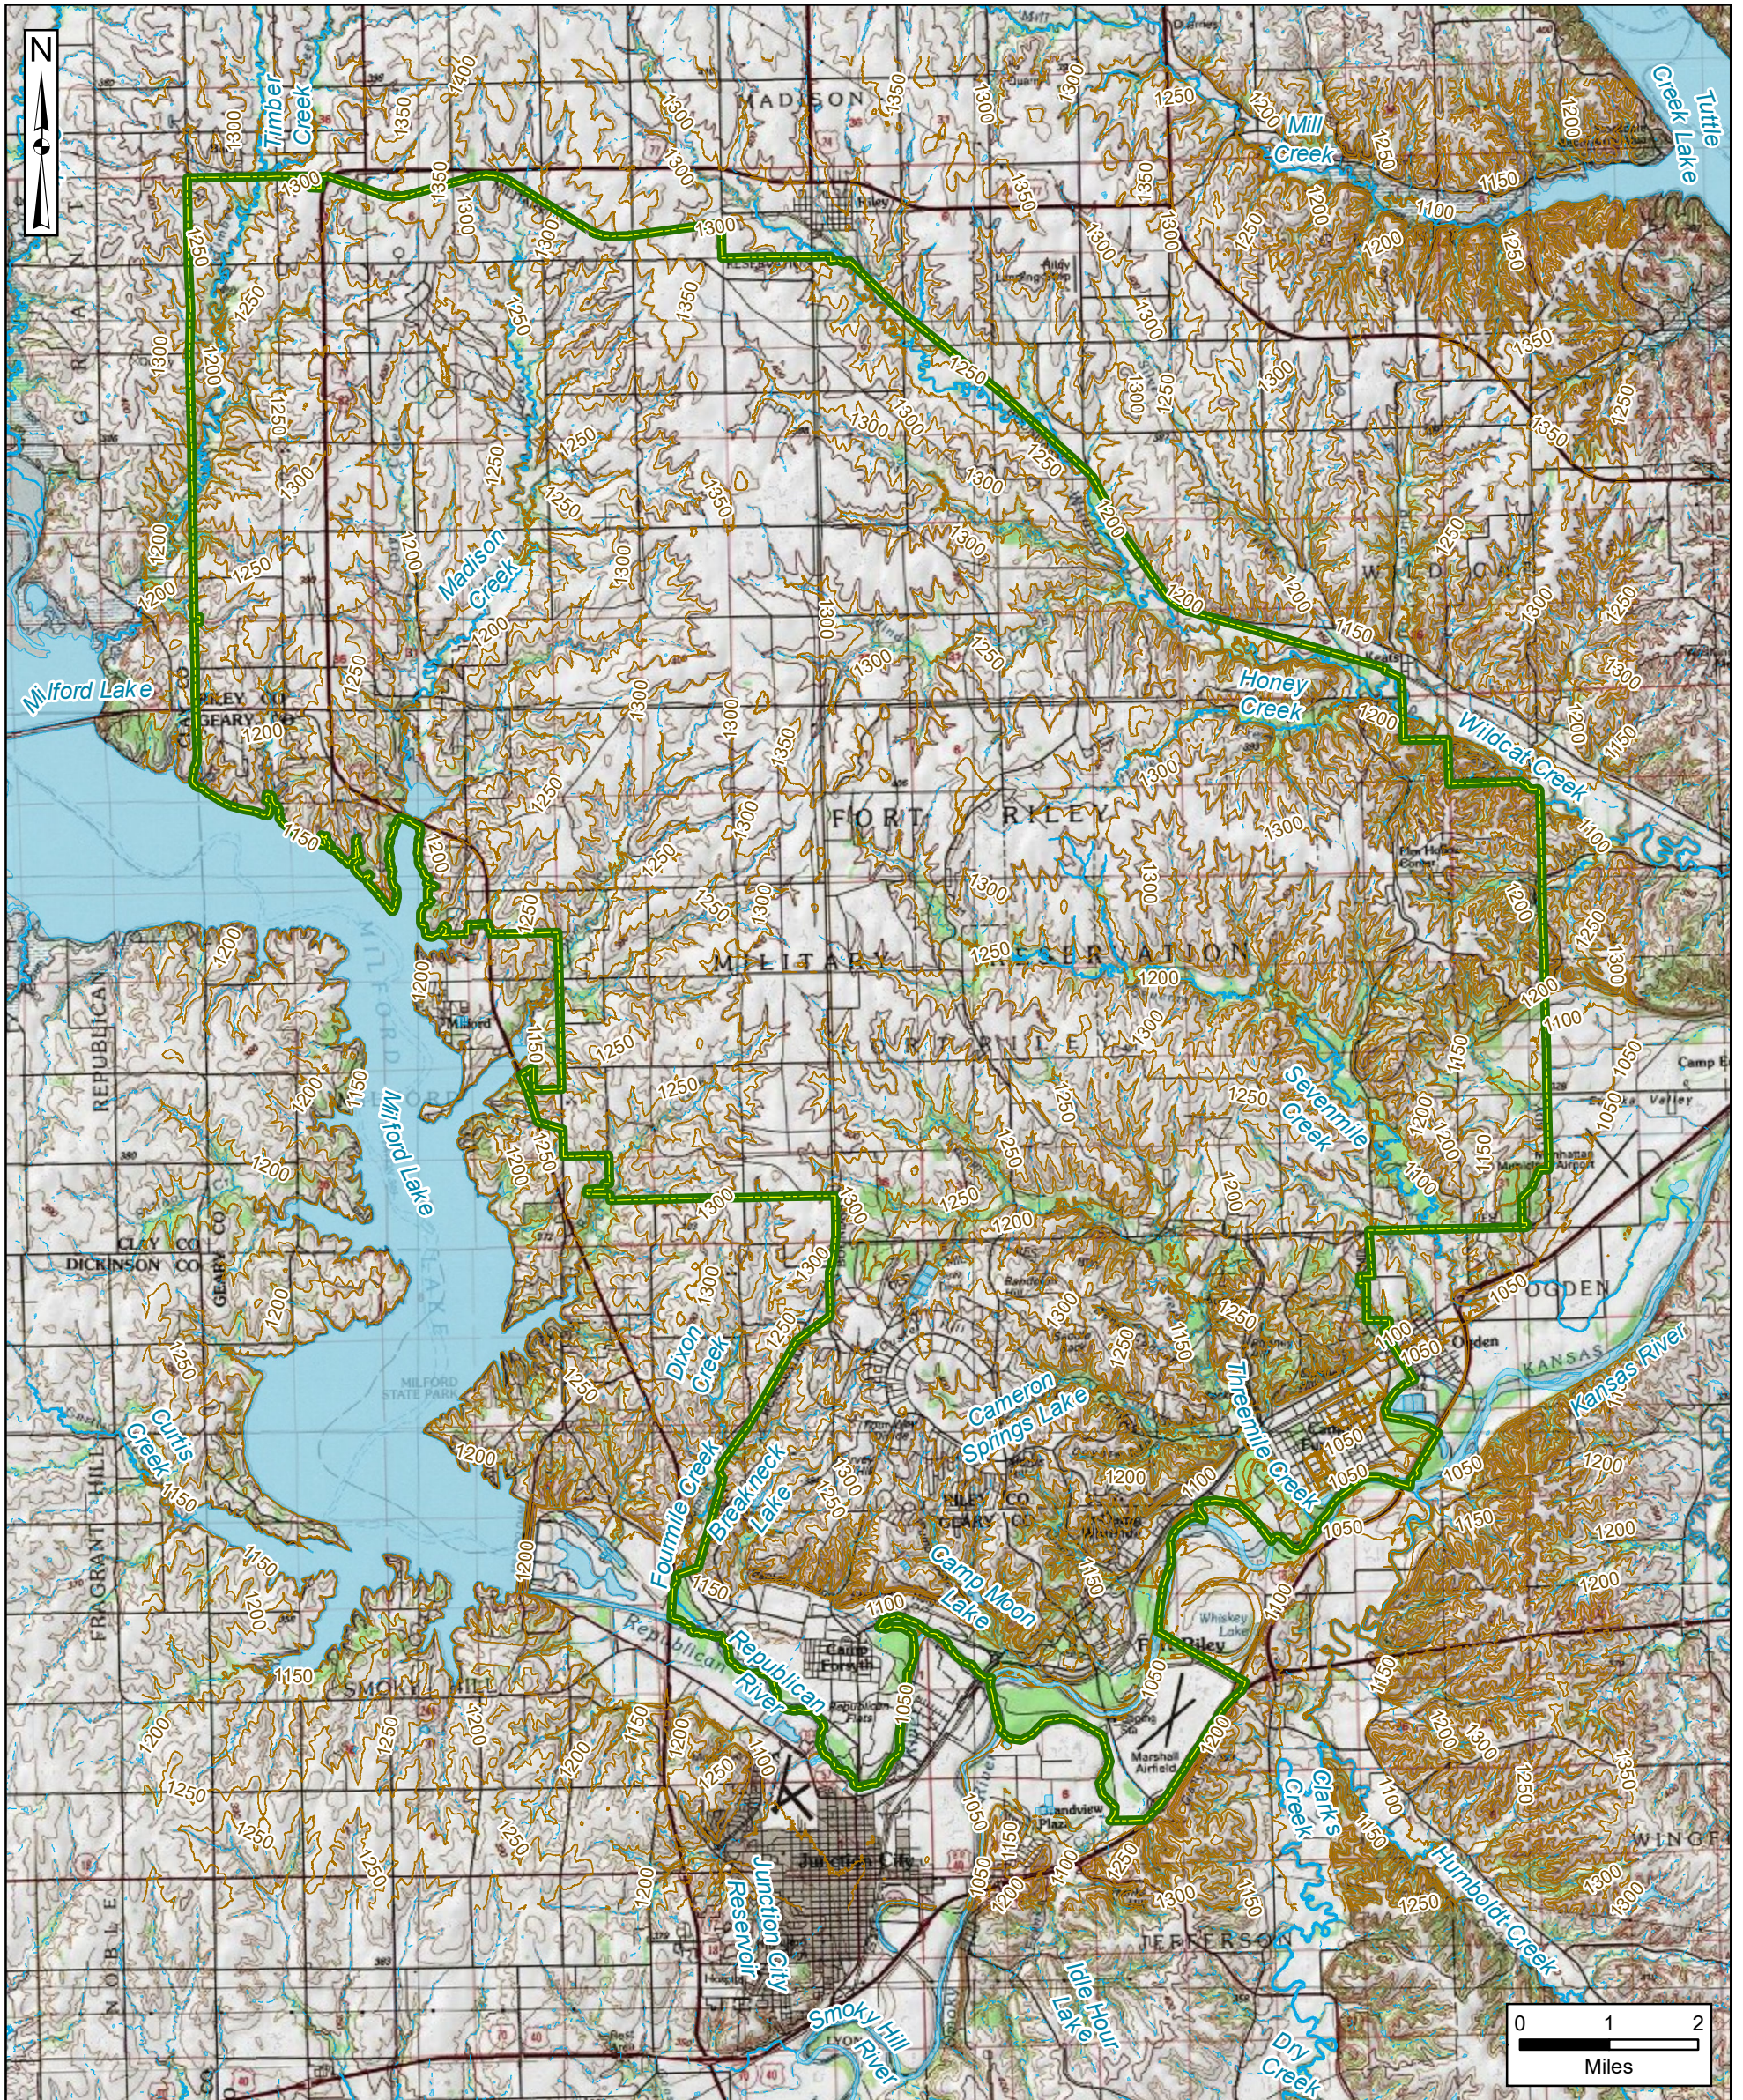
Figure 2-3
Topographic Map

Elevations at FTRI range from approximately 1,000 feet to approximately 1,400 feet above mean sea level. The terrain at the installation varies from alluvial floodplains along the Republican and Kansas rivers on the southern portion of the installation, through hilly to steep lands in the central and eastern portions, to the uplands regions in the northern and western portions (Fort Riley 2001a; Malcolm Pirnie 2009). The topography at FTRI is illustrated on **Figure 2-3**.

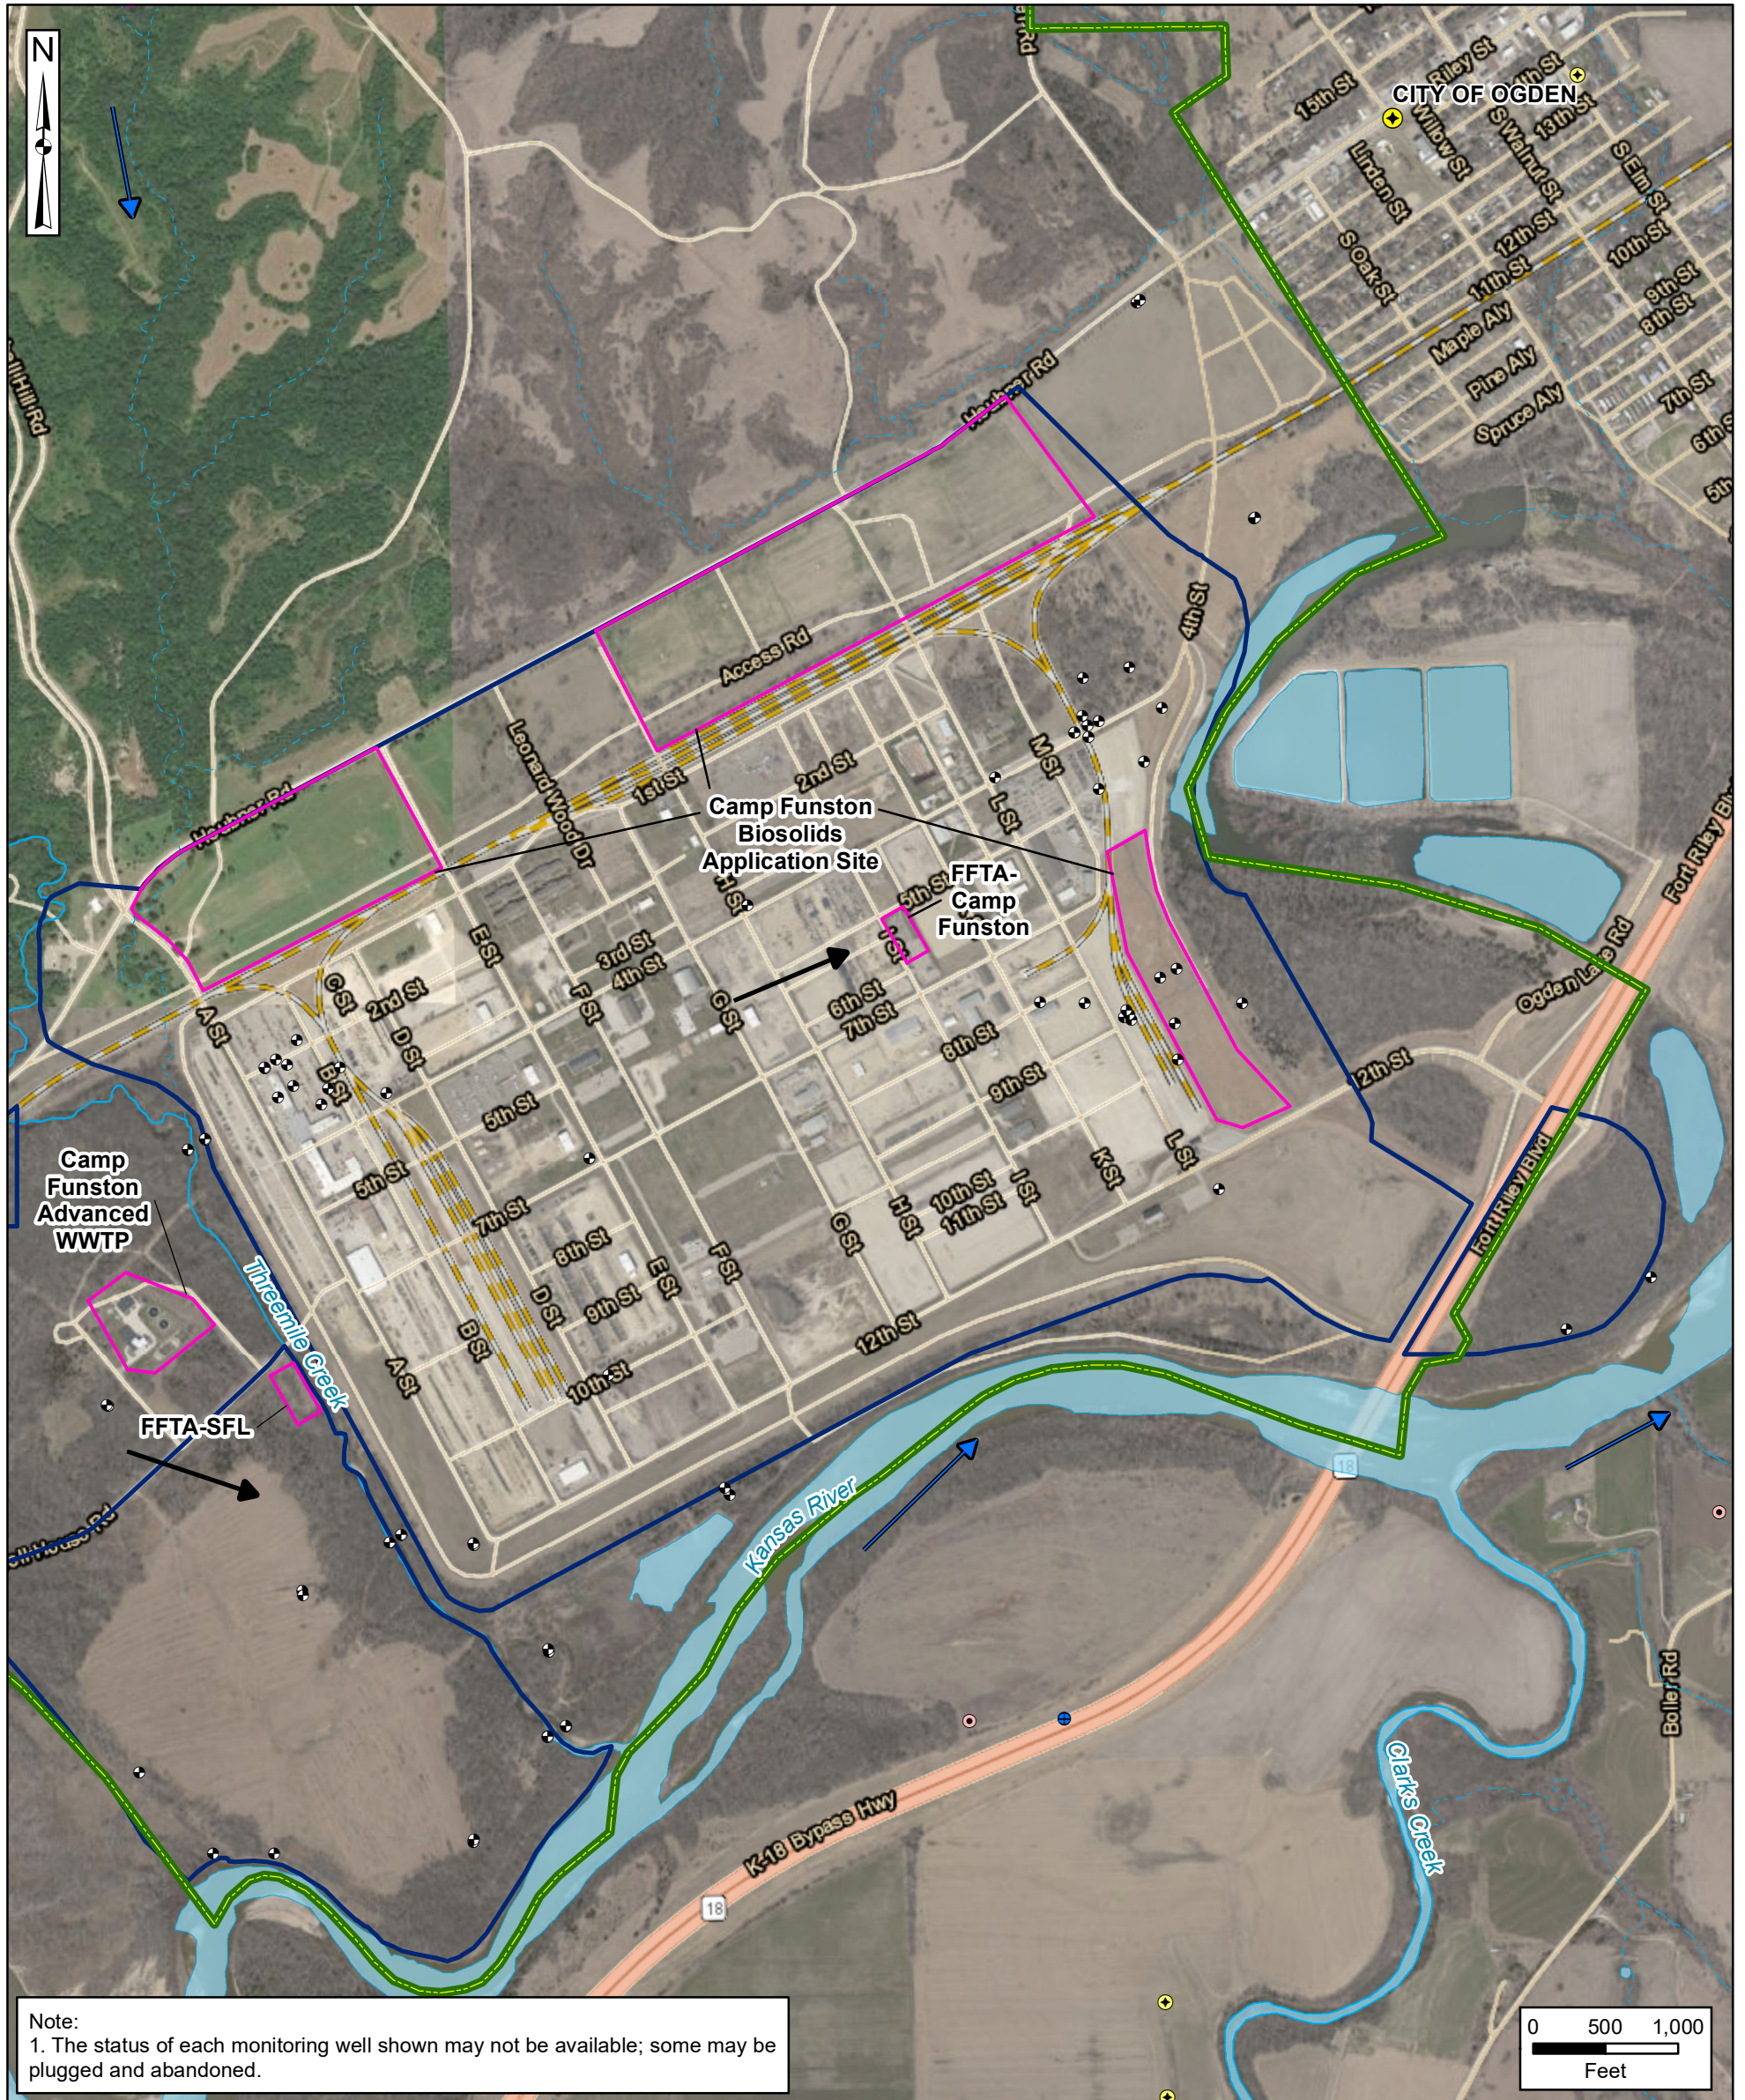
Figure 5-4
Aerial Photo of the
Camp Funston AOPIs

The FFTA-SFL (FTRI-028, OU 001, 20605.1027) was identified as an AOPI due to historical fire training activities (**Figure 5-4**). The training area has been described as an elevated, large-diameter "drum", with an overall size of 150 by 200-feet, into which flammable liquids (e.g., JP-4, diesel, oil, MOGAS) were poured, ignited, and extinguished with AFFF. The top six inches of soil was removed from this site when it was closed in 1982 and was disposed in the Whitside C/D Landfill (FTRI-002). The site is located within 100-feet of Threemile Creek, at the end of Well House Road, off the western border of Camp Funston and east of the SFL.

The FFTA-Camp Funston was identified as an AOPI due to historical fire training activities (**Figure 5-4**). The FFTA-Camp Funston was a former training pit to which propane was piped and the area was used for fire training exercises. It is unknown if AFFF was used during these training exercises at this area, although personnel interviews indicated it was unlikely. An adjacent helicopter shell was also used for fire training activities where the historical use/application of AFFF was confirmed. The exact dates of AFFF releases to this area is unknown and the installation personnel with knowledge of this area indicated AFFF was likely only released 5 to 10 times, as foam was not used for regular training activities due to its corrosive nature. The current and anticipated future land use is industrial/commercial at the FFTA-Camp Funston.

The Camp Funston Advanced WWTP was identified as an AOPI following records research, personnel interviews, and site reconnaissance due to the treatment of wastewater potentially containing PFAS (**Figure 5-4**). The WWTP began operations in 2011 and it is currently the only active WWTP at FTRI. This WWTP received all recent foam releases at the MAAF. The current and anticipated future land use is industrial/commercial at the Camp Funston Advanced WWTP.

The Camp Funston Biosolids Application Site was identified as an AOPI following records research, personnel interviews, and site reconnaissance due to the historical placement of biosolids potentially containing PFAS (**Figure 5-4**). Biosolids from the Main Post WWTP, which potentially contained PFAS due to historical releases of AFFF to the sanitary sewer system at the MAAF, were land-applied at this site prior to 1996. The Camp Funston Biosolids Application Site has three separate application fields, all of which historically received biosolids. The current and anticipated future land use is industrial/commercial at the Camp Funston Biosolids Application Site.

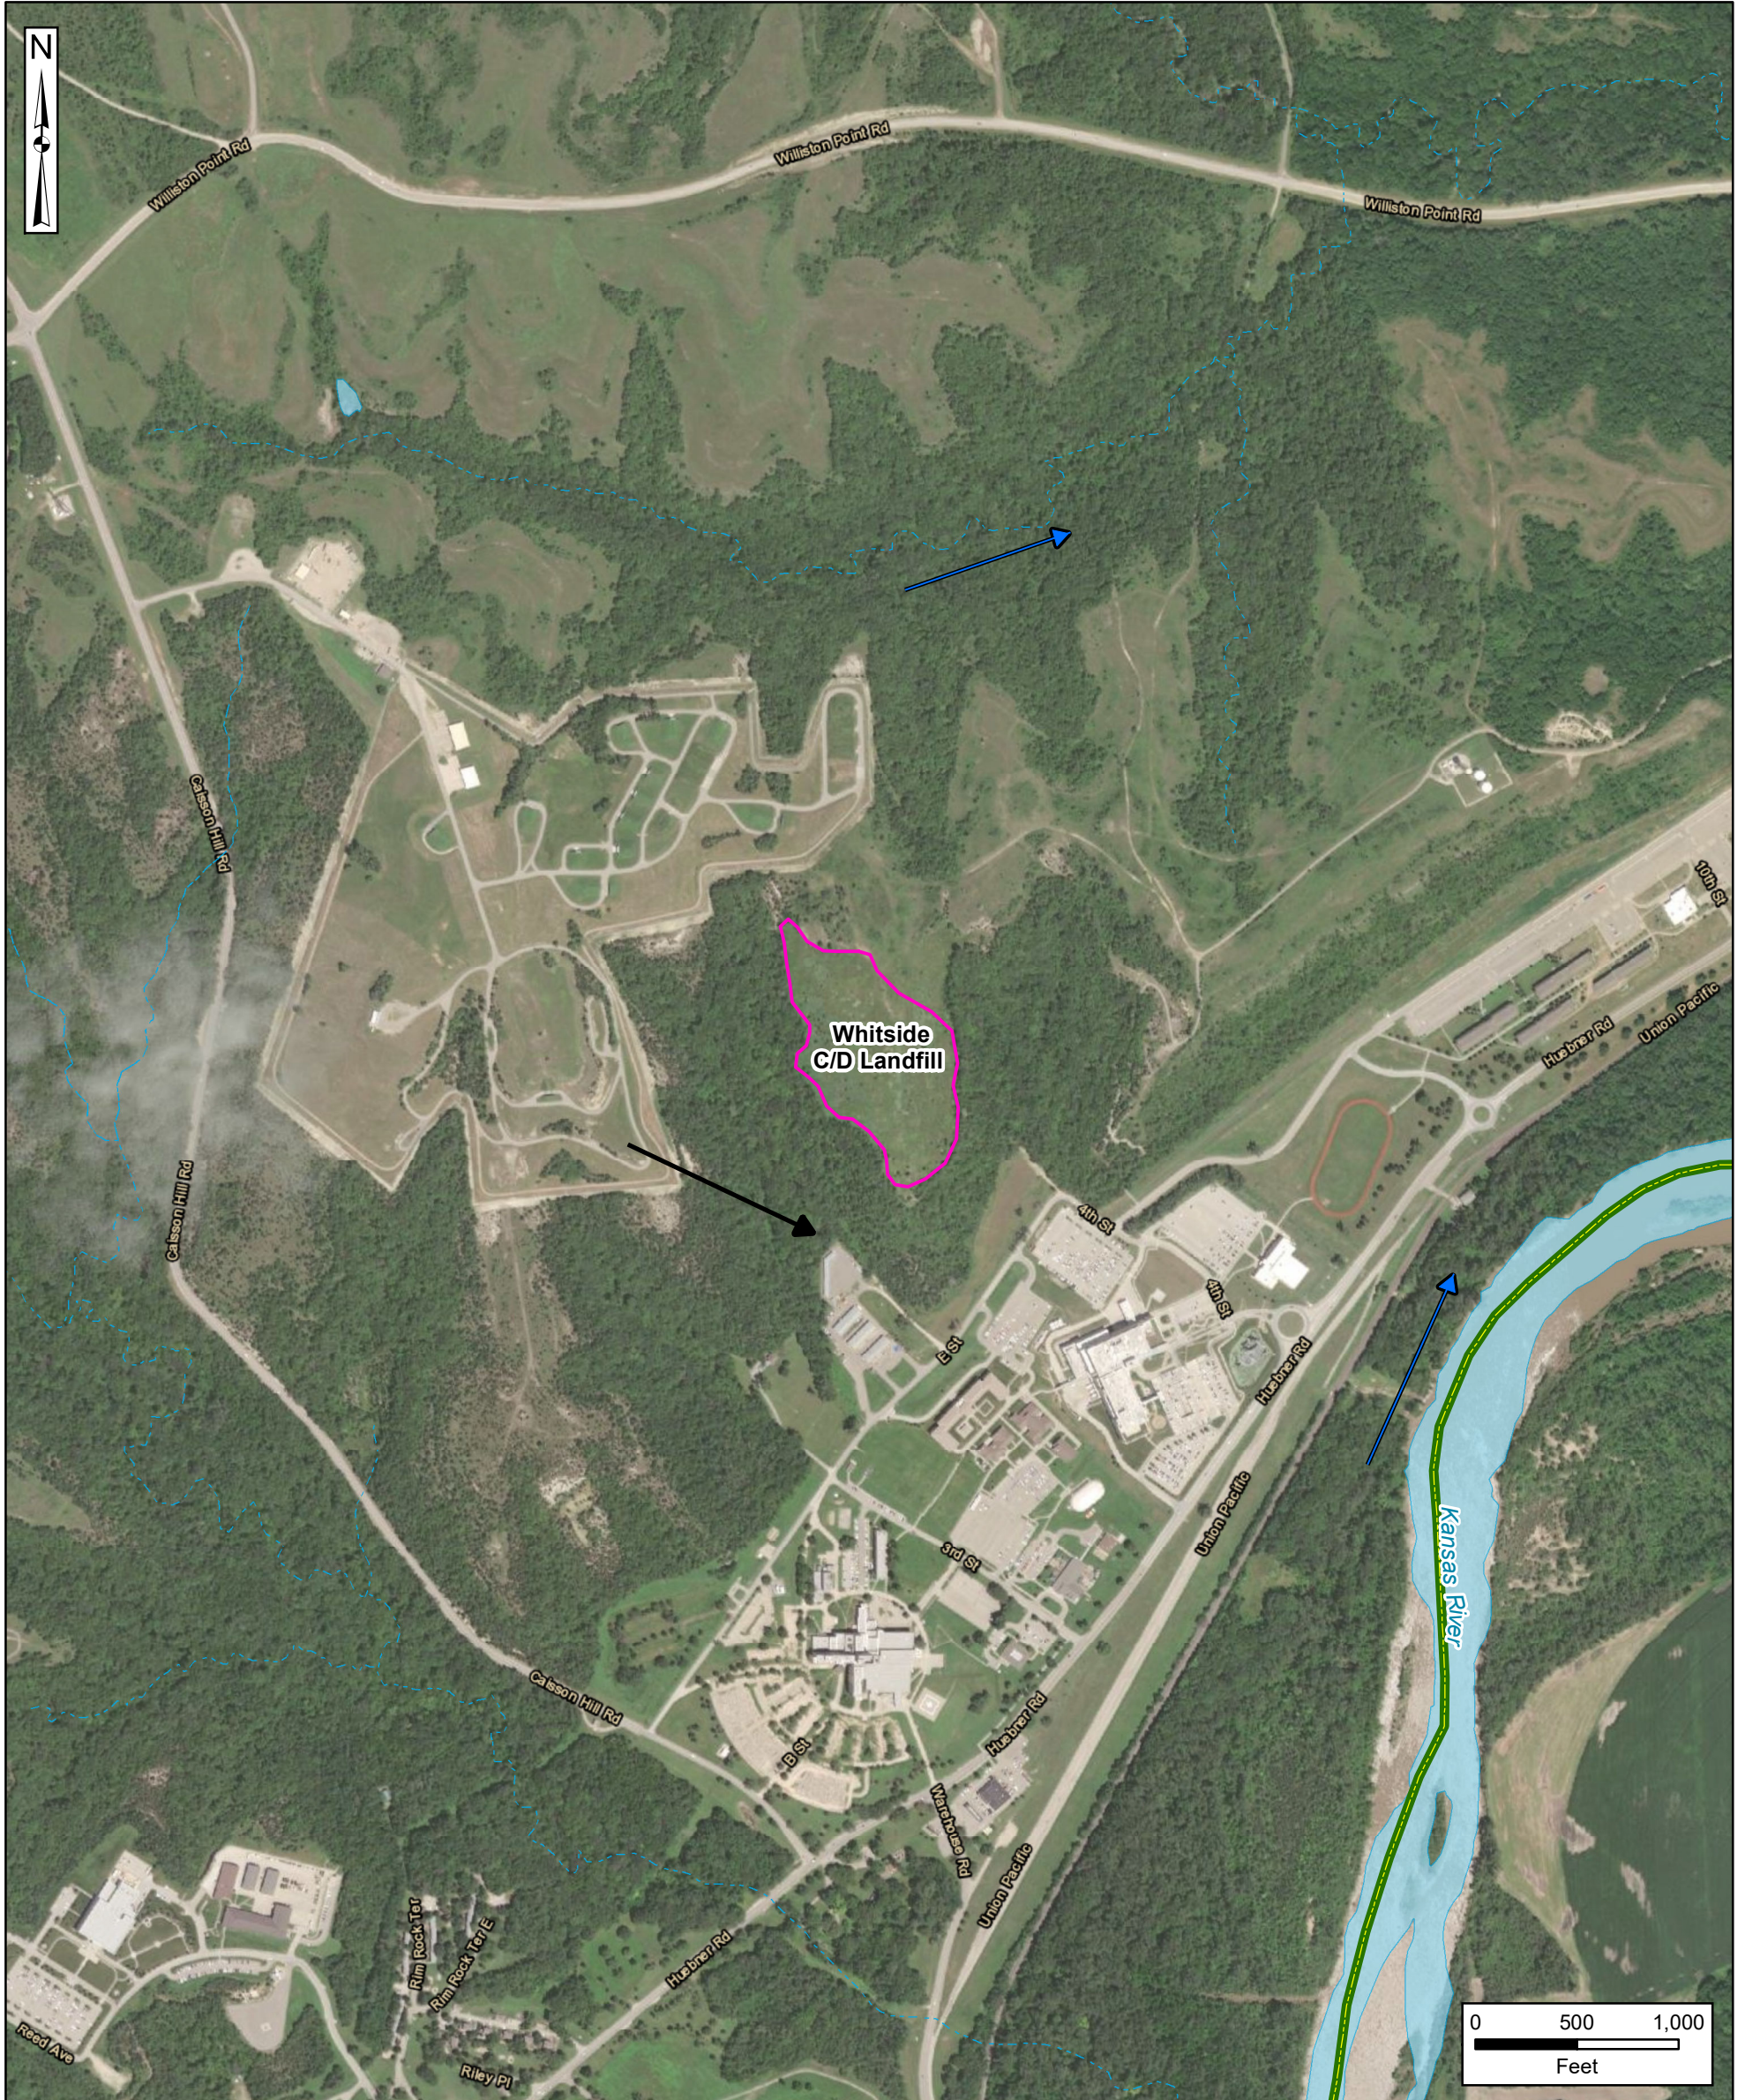
Figure 5-5
Aerial Photo of the
Whitside C/D Landfill AOP

The Whitside C/D Landfill (FTRI-002, 20605.1002) was identified as an AOPI following personnel interviews, and site reconnaissance due to disposal of soil and construction debris potentially containing PFAS (**Figure 5-5**). In 1982, the landfill received potentially PFAS-impacted soil excavated from FFTA-SFL (FTRI-028). The former C/D landfill operated from 1980 to 2002 and is unlined. Disposal consisted primarily of traditional C/D debris such as wood, concrete, and metal as well as smaller items such as appliances, drums (nonhazardous waste or empty), and organic/vegetative wastes.

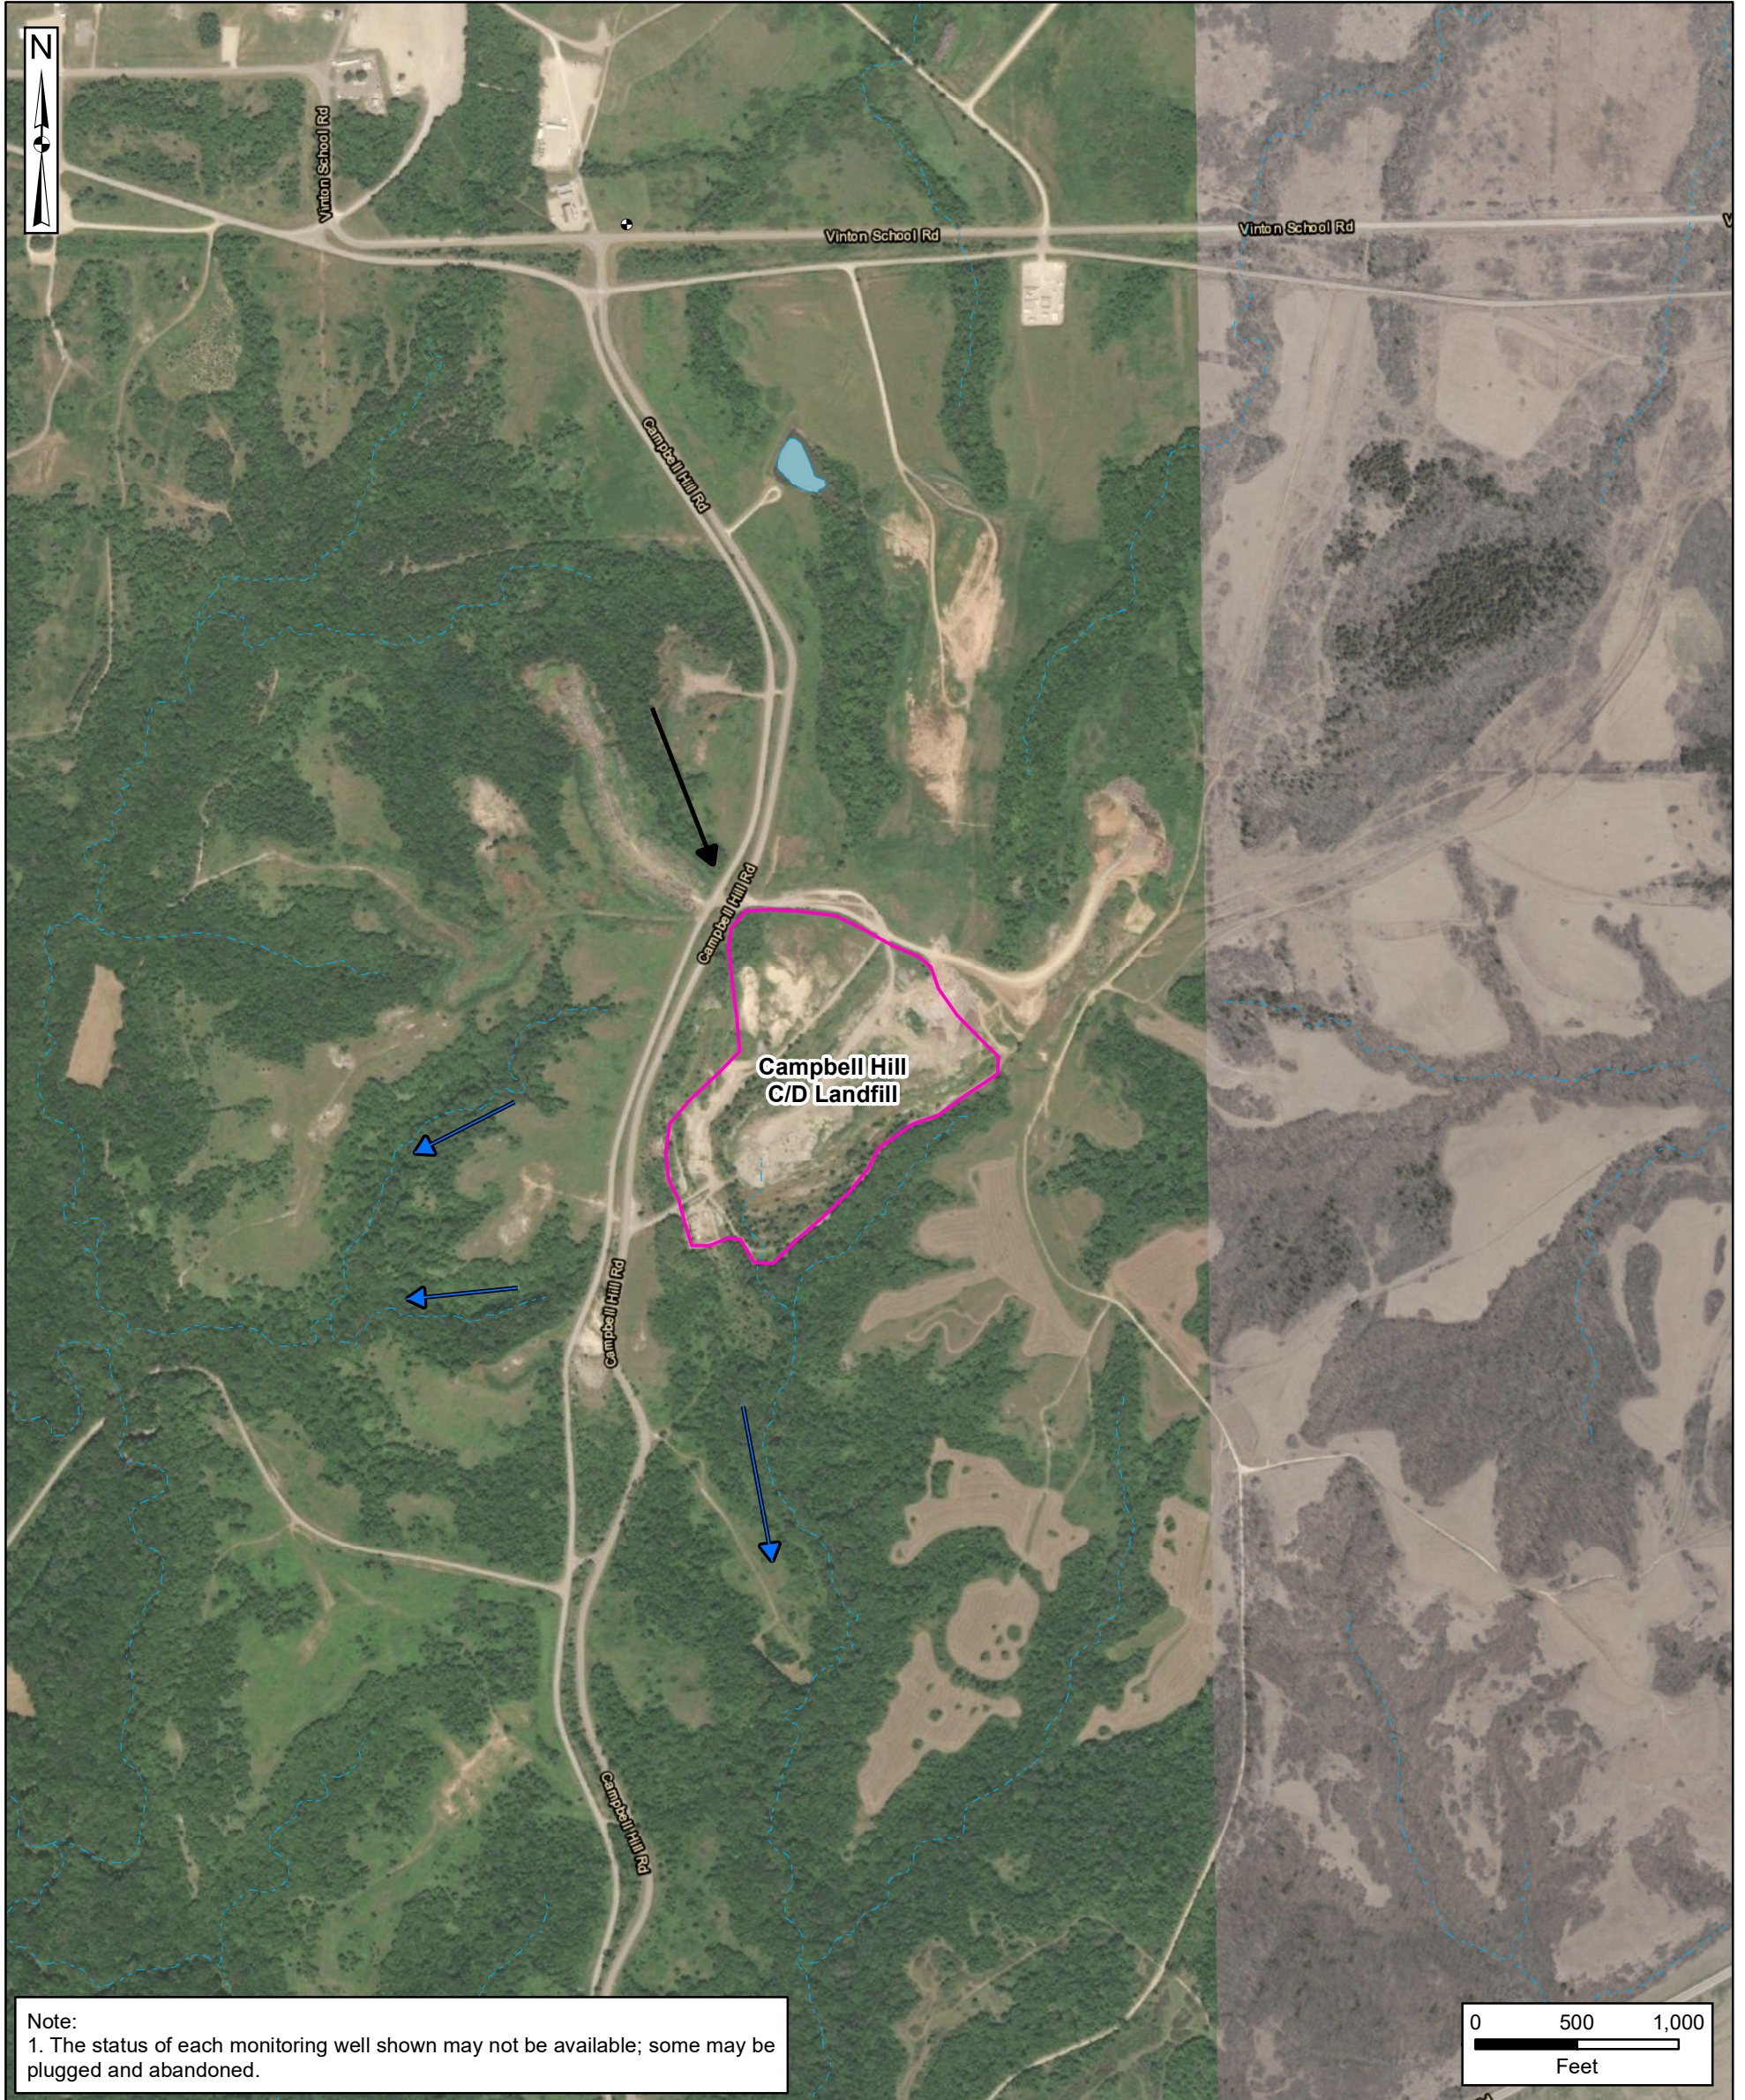
Figure 5-6
Aerial Photo of the
Campbell Hill C/D Landfill AOP

The Campbell Hill C/D Landfill was identified as an AOPI following personnel interviews, and site reconnaissance due to disposal of soil and construction debris potentially containing PFAS (**Figure 5-6**). The active unlined C/D landfill began operation in 2000 and received potentially PFAS-impacted soil and concrete excavation debris from the Old Taxiway at the MAAF after the airfield was remodeled in 2010. AFFF was used at the Old Taxiway during fire training exercises. The current and anticipated future land use is industrial/commercial at the Campbell Hill C/D Landfill.

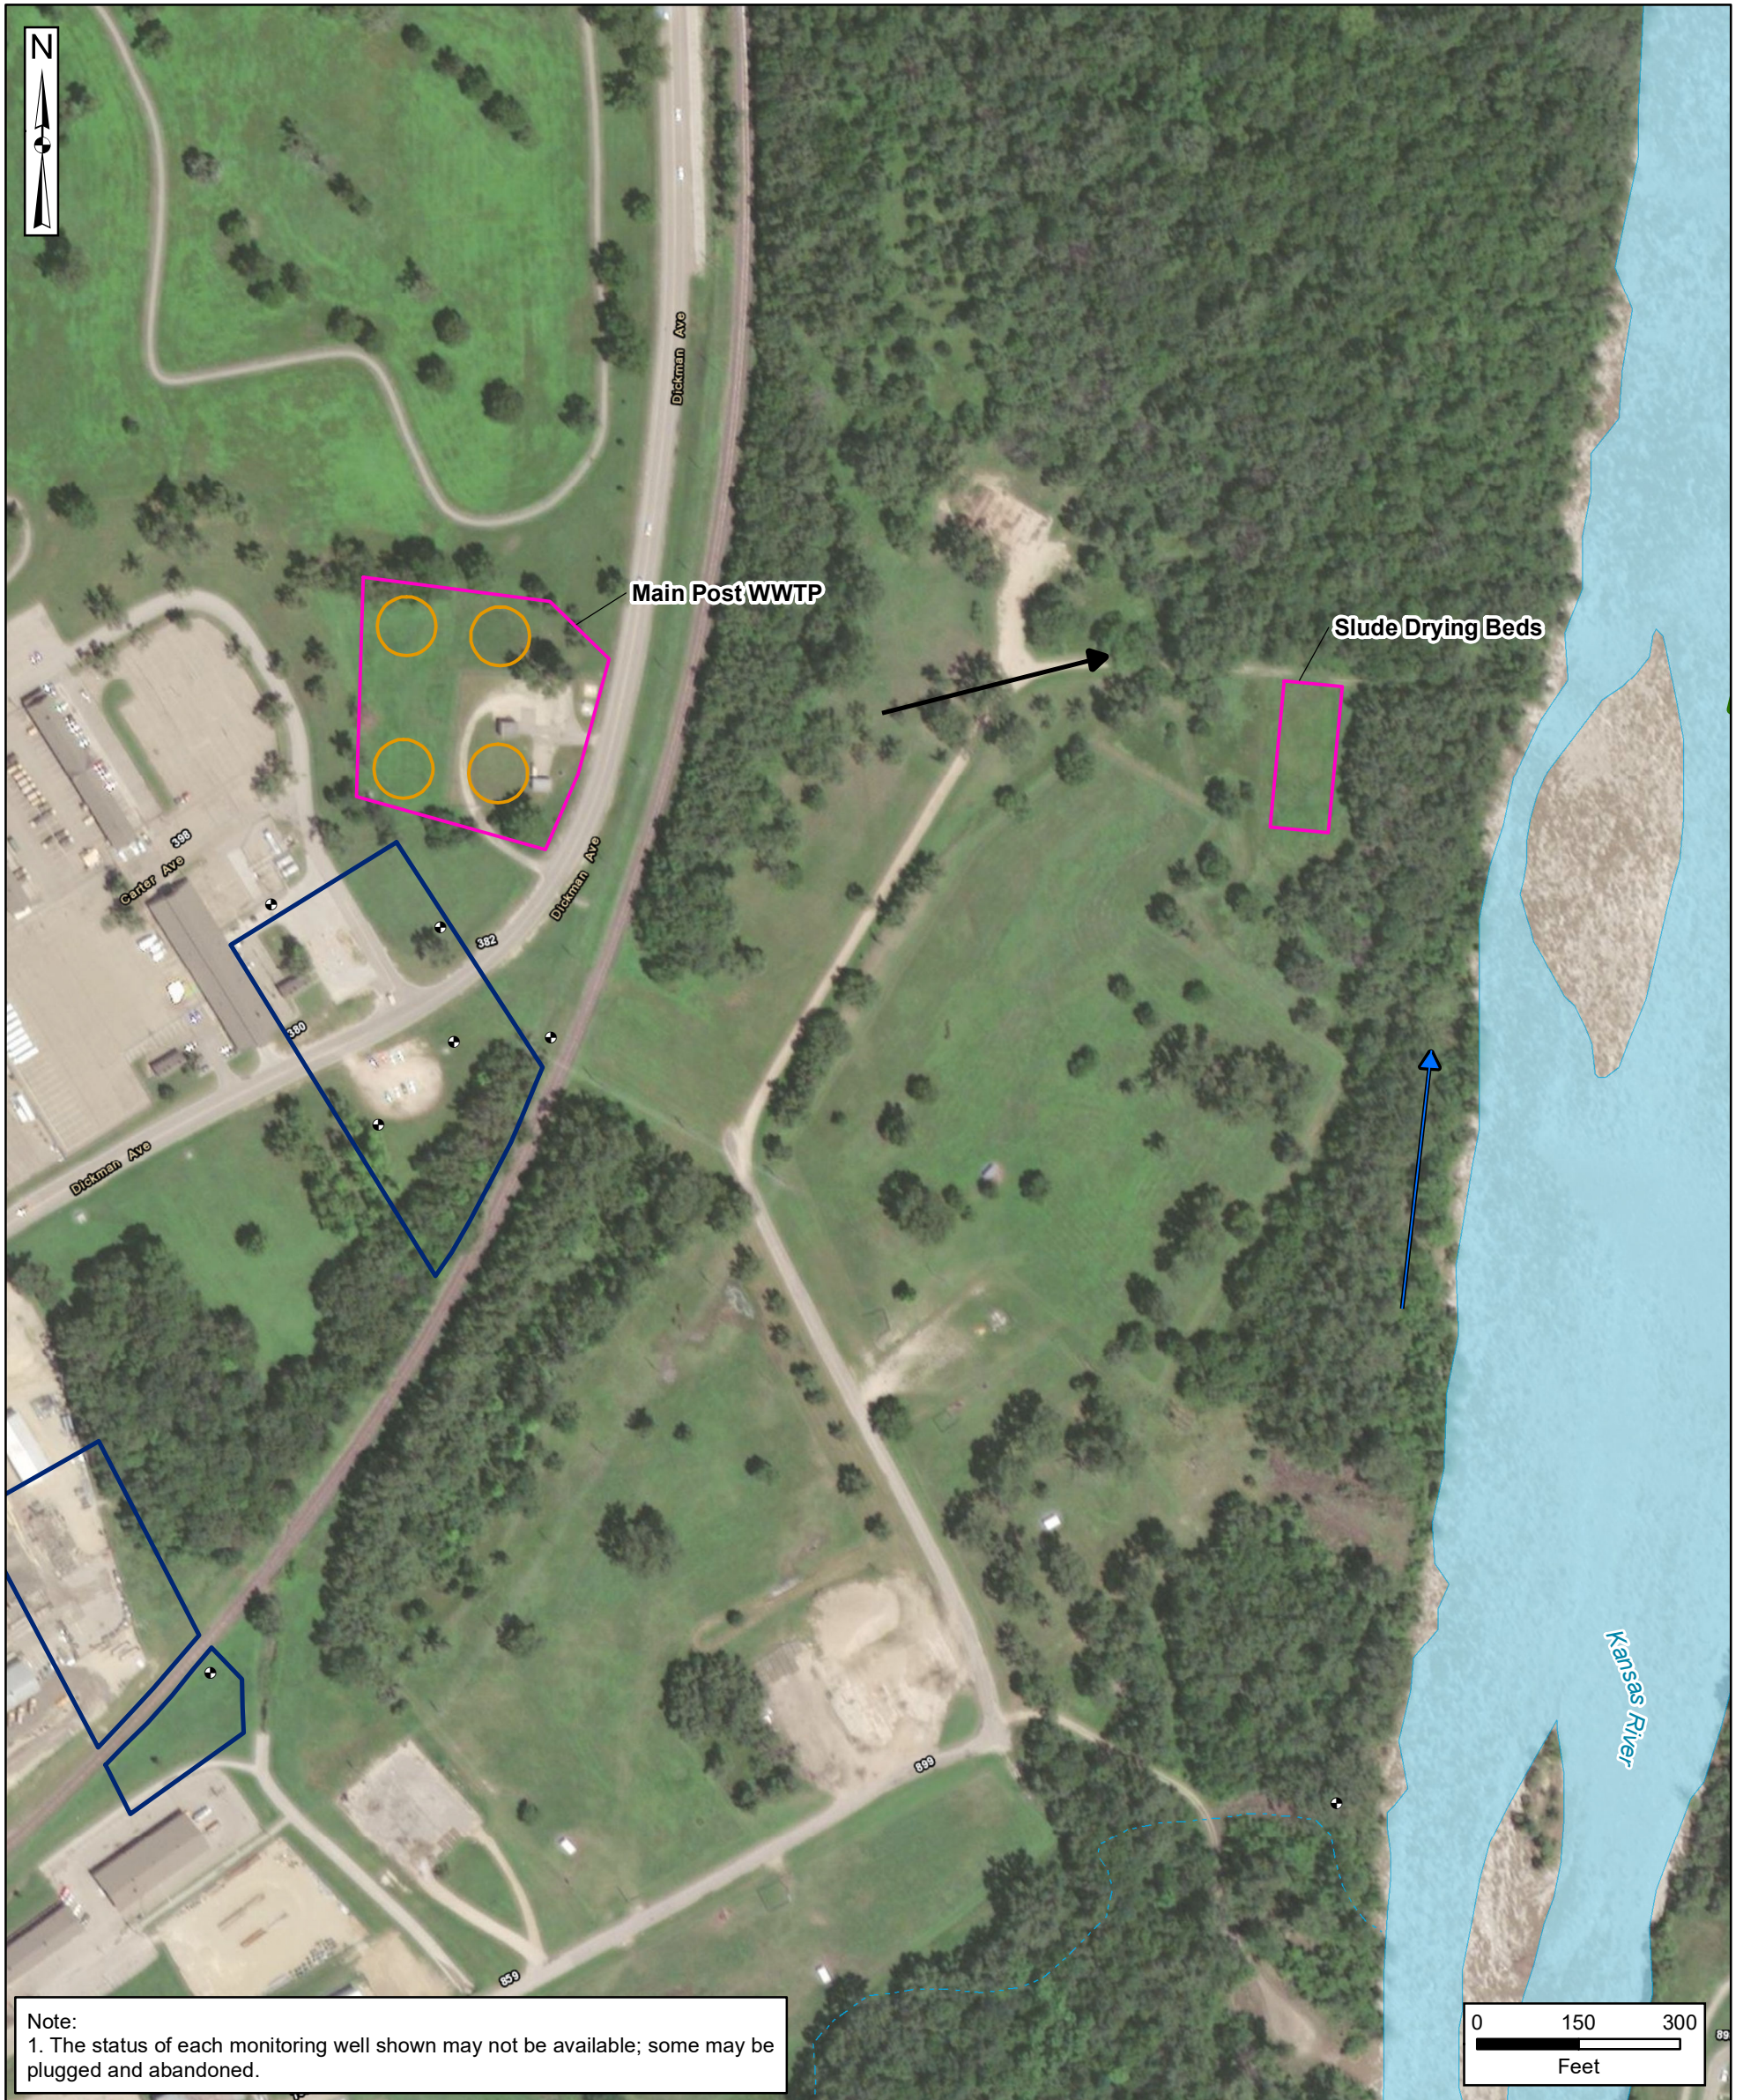
Figure 5-8
Aerial Photo of the
Main Post WWTP and Sludge Beds AOPI

The Main Post WWTP and Sludge Beds (FTRI-025, 20605.1024) were identified as an AOPI following records research, personnel interviews, and site reconnaissance due to the treatment and storage of wastewater and sludge potentially containing PFAS (**Figure 5-8**). The former WWTP operated from 1940 until 2005 when it was decommissioned. It treated wastewater generated from the Main Post, the MAAF, Camp Whitside, and Camp Funston areas. Historical foam releases at the MAAF drained to the sanitary sewer system into this WWTP.
