FINAL **PRELIMINARY ASSESSMENT** **AND SITE INSPECTION OF** **PER- AND** **POLYFLUOROALKYL** **SUBSTANCES**

Fort Riley, Kansas

January 2022

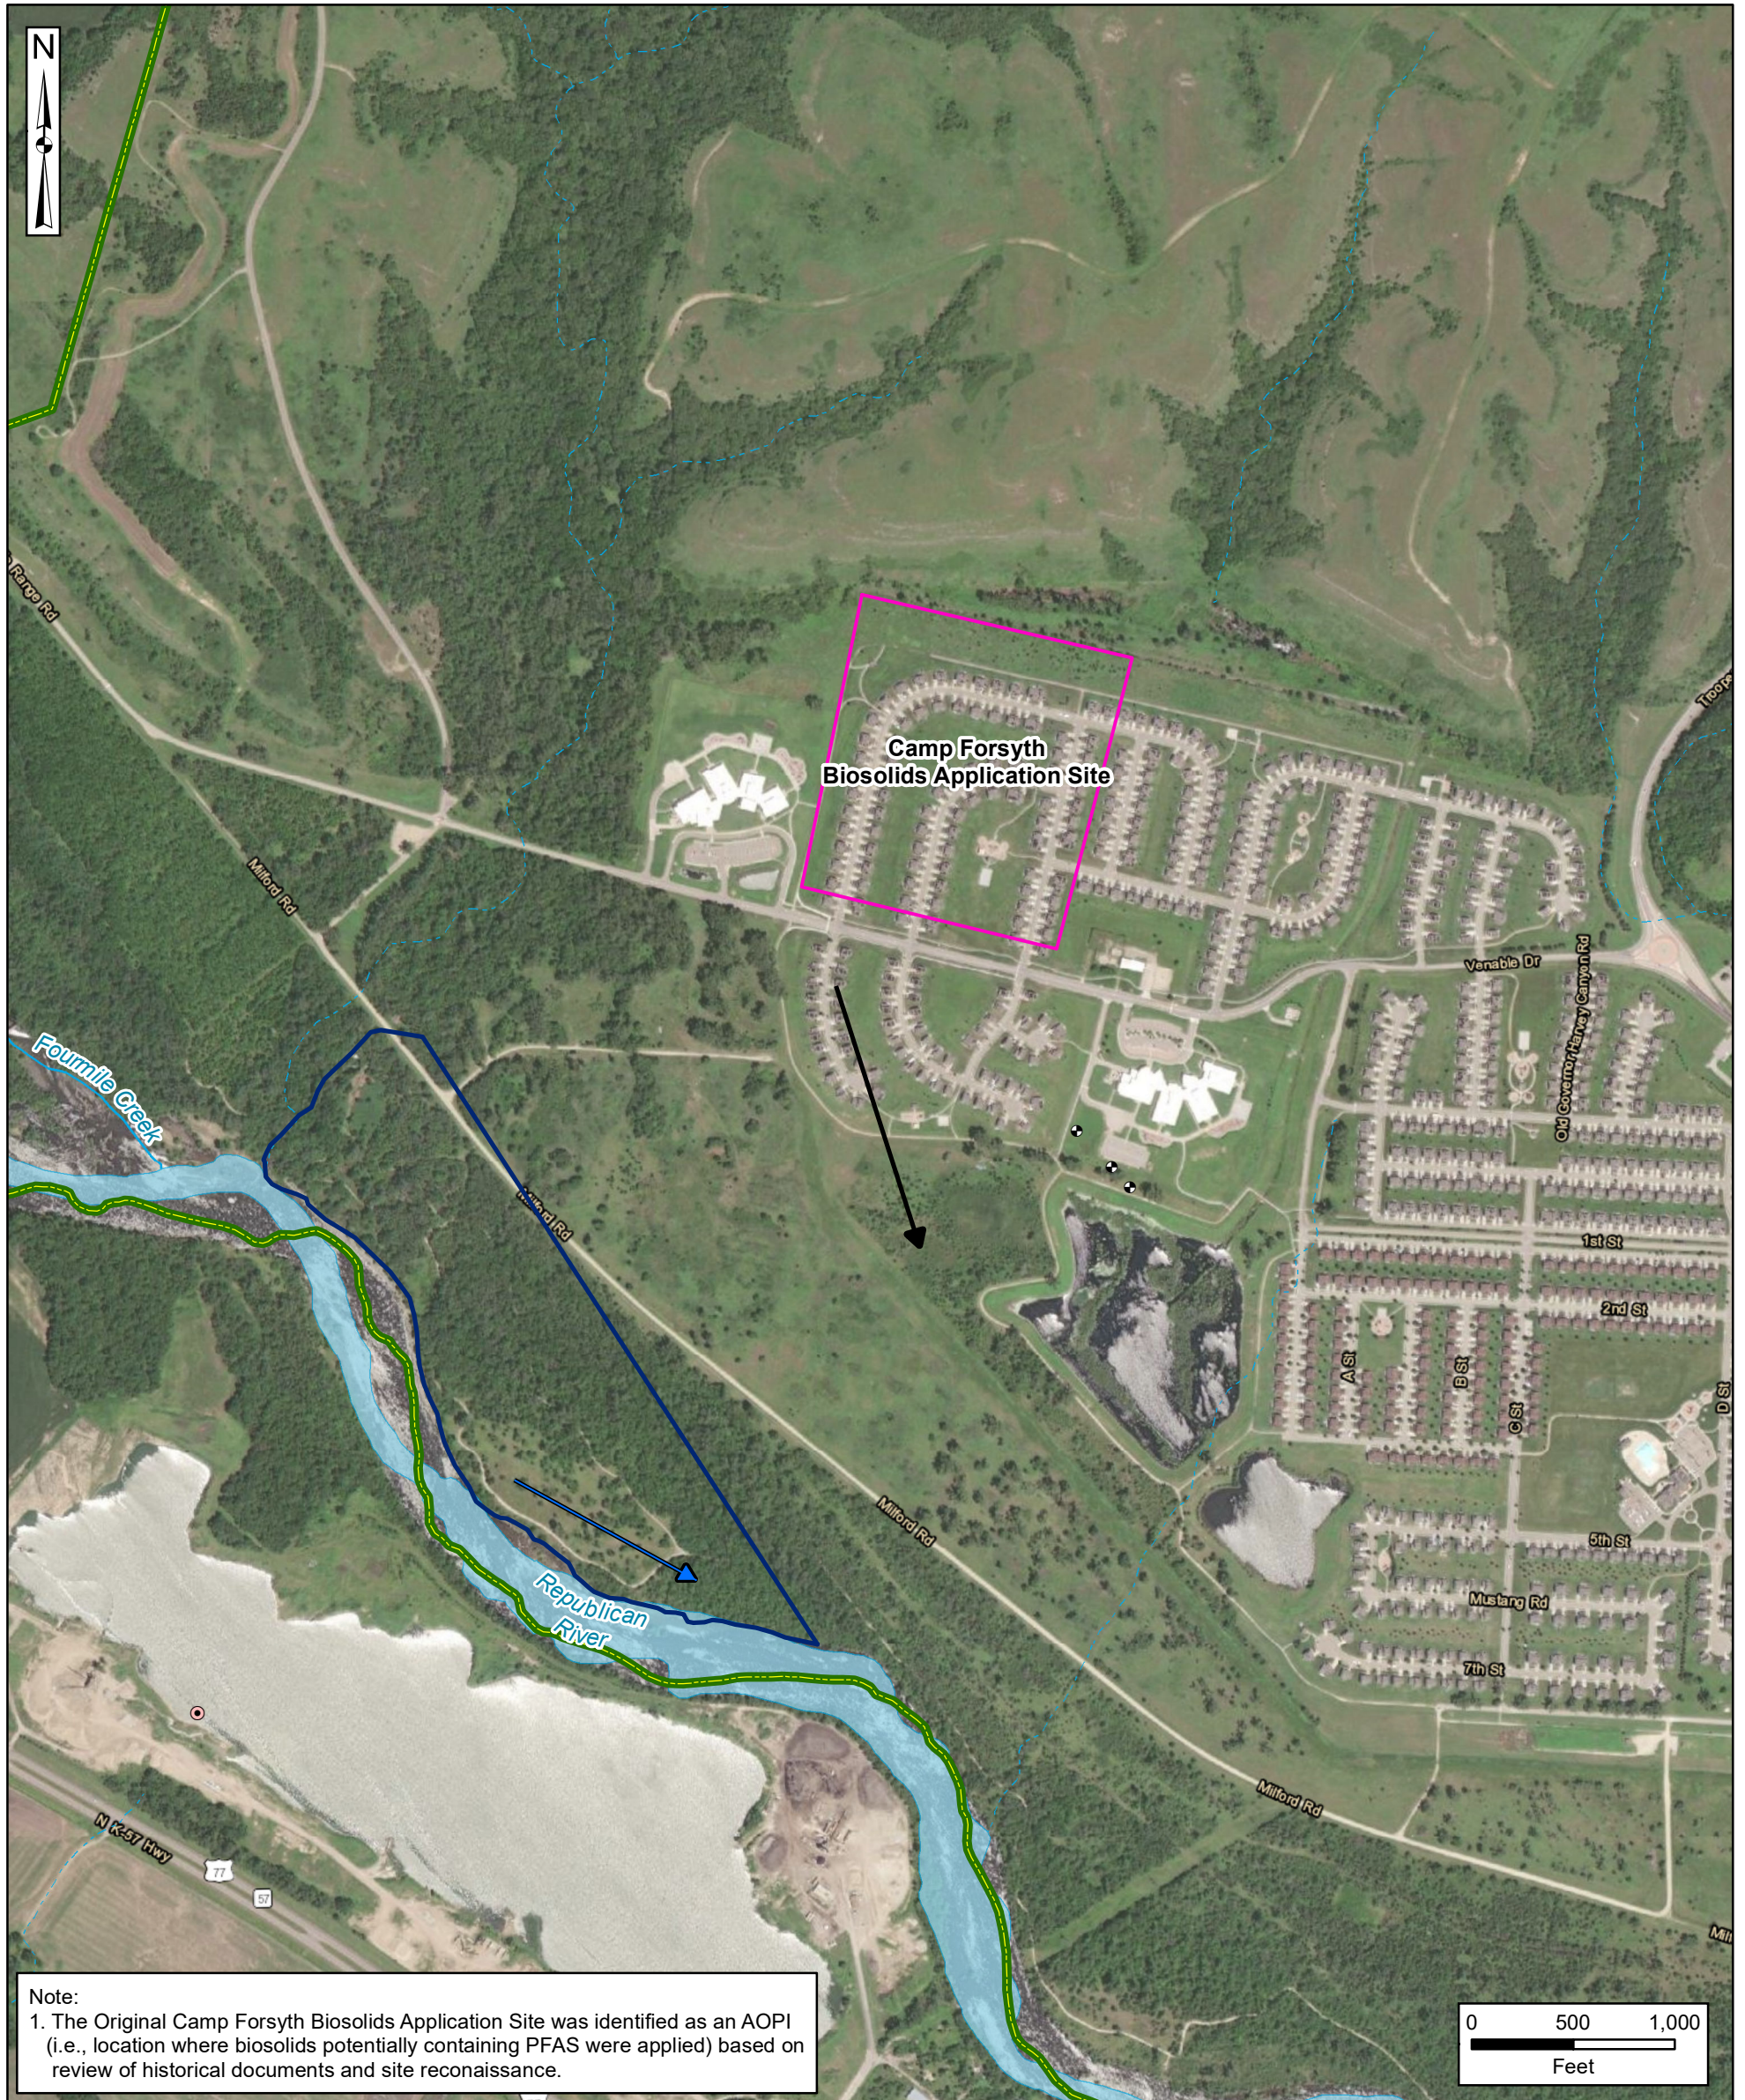
Figure 5-13
Aerial Photo of the
Camp Forsyth Biosolids Application Site AOP

The Camp Forsyth Biosolids Application Site was identified as an AOPI following records research, personnel interviews, and site reconnaissance due to the historical placement of biosolids potentially containing PFAS (**Figure 5-13**). Biosolids application records indicated that the Camp Forsyth Original Site (not the Expansion Site) received biosolids from the Main Post WWTP in 2004 and 2006. The biosolids potentially contained PFAS due to historical releases of AFFF to the sanitary sewer system at the MAAF. The current and anticipated future land use is residential at the Camp Forsyth Biosolids Application Site.

Note:
1. The Original Camp Forsyth Biosolids Application Site was identified as an AOP (i.e., location where biosolids potentially containing PFAS were applied) based on review of historical documents and site reconnaissance.
