FINAL
SUMMARY TECHNICAL MEMORANDUM
COMPOSITE SURFACE SOIL SAMPLING EVENT
SHERMAN HEIGHTS SMALL ARMS RANGE (SHSAR) IMPACT SLOPE

FORT RILEY, KANSAS

SUMMARY TECHNICAL MEMORANDUM COMPOSITE SURFACE SOIL SAMPLING EVENT
SHSAR IMPACT SLOPE - FORT RILEY, KANSAS

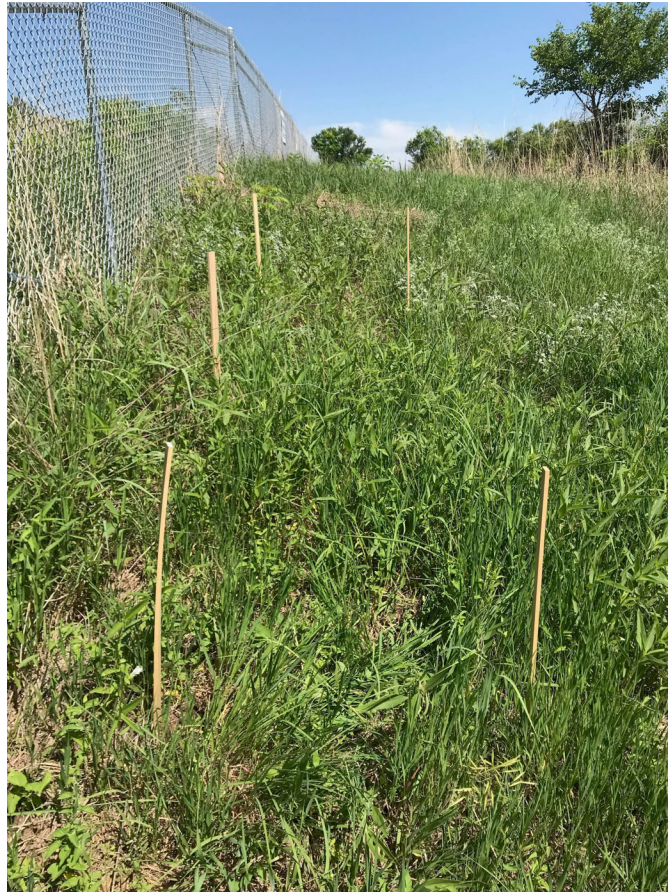
Figure 1: Survey laths indicating soil sampling locations are observed along the south perimeter of the SHSAR. Image taken facing East.

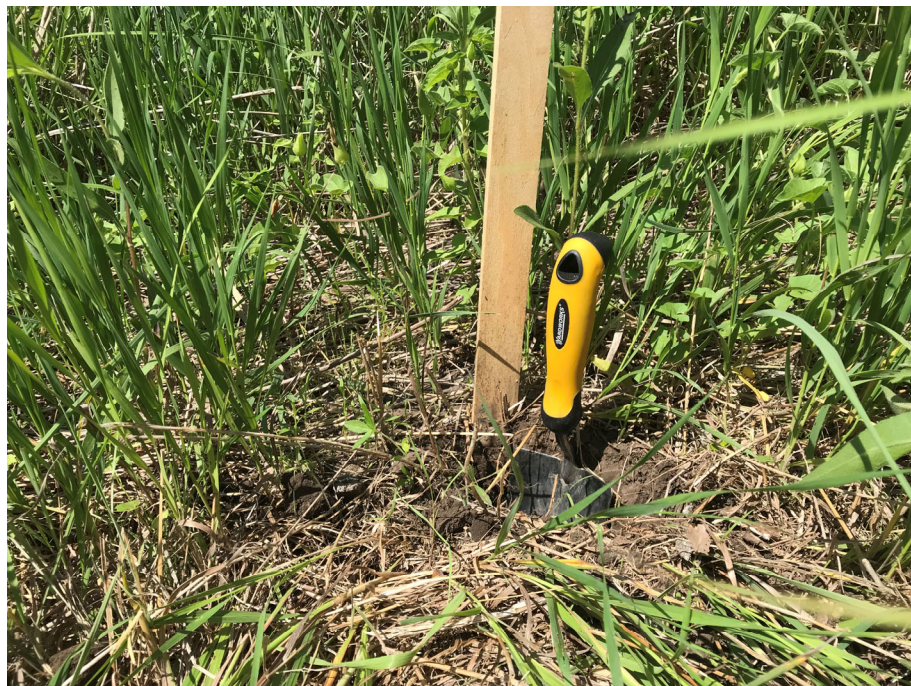
Figure 2: Composite soil sampling location observed with a garden trowel for scale. To avoid cross contamination, a different trowel was used for each composite sample, and discarded after.

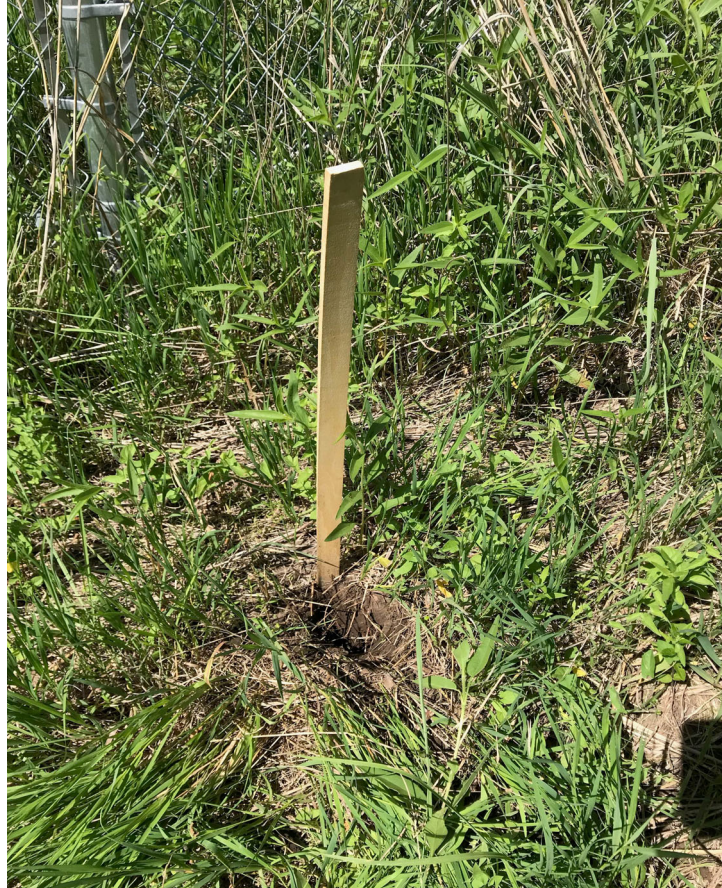
Figure 3: Composite soil samples were collected to depths of 0-0.5'.
The samples were collected as close to the surveyed stakes as possible.
